South Coast Dredging Association

Regional Environmental Assessment: Coastal Characterisation

Technical Note DDR4323-02

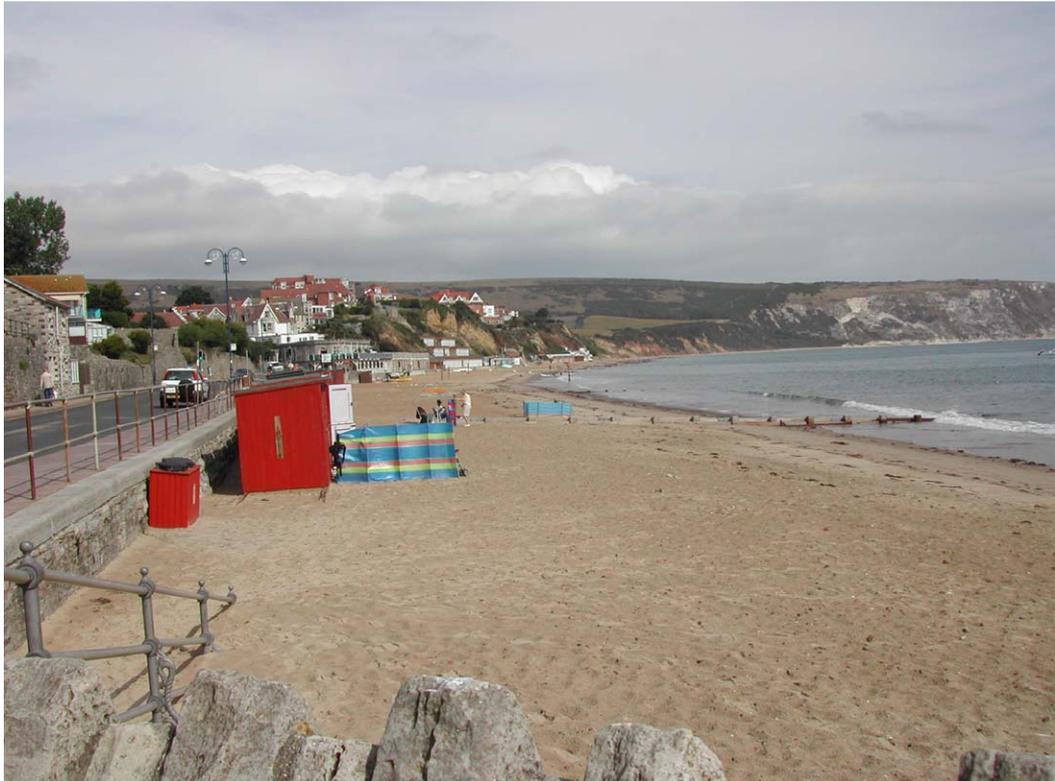
Plate 1 Central part of Swanage Bay post recharge (2008)

Swanage Bay is contained by the chalk headland of Ballard Point to the North and the limestone headland of Peveril Point to the South. The beaches (Plate 1) within it are largely the result of local erosion of the cliffs which results in the release of sand and flint pebbles along with finer materials which are generally thought to be transported offshore. Beach material becomes finer in a southwards direction, with a relatively abrupt decrease in the proportion of upper beach gravel south of the most northerly section of seawall / promenade.

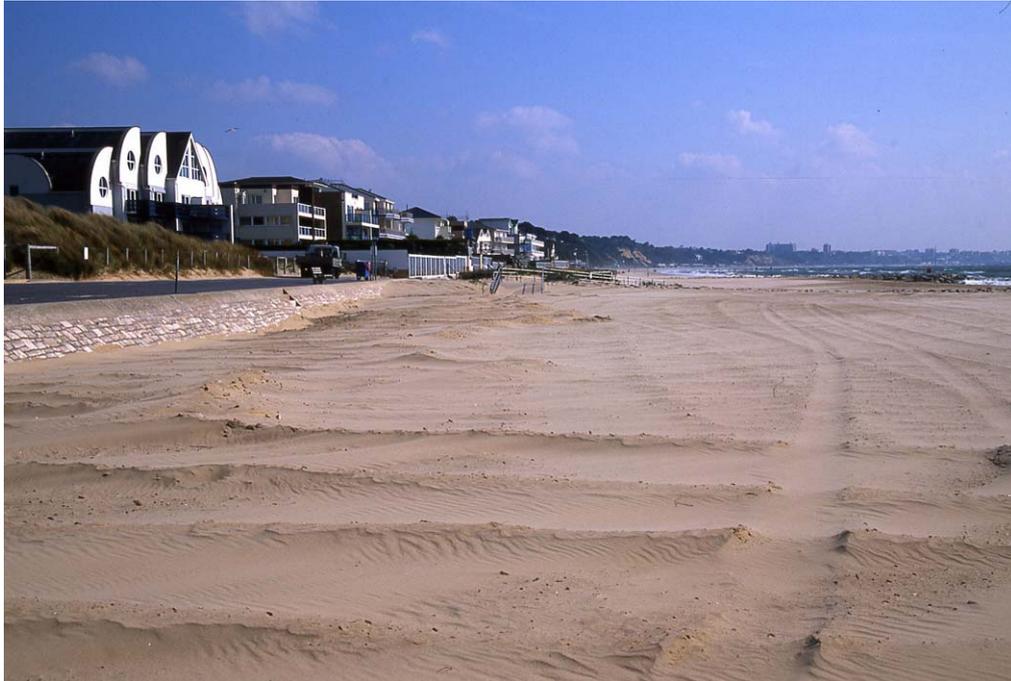
Plate 3 Sandbanks, east of Pavilion (2005)

The Sandbanks peninsula, which is backed by dunes and high value properties (Plate 3), extends from the harbour entrance northwards to Poole Head, from where the sand beaches continue below cliffs that are protected at their base by seawalls (Maps 1 and 3). Historically, beach levels were very volatile, but after groynes were built there was a general improvement that lasted until the 1980s. However, by then the groynes had become dilapidated and ineffective, resulting in a return to erosion that was particularly serious near the entrance to Poole Harbour. Prior to the construction of the seawalls and groynes within Poole Bay, the peninsula benefited from the erosion of the sandy cliffs within the bay.

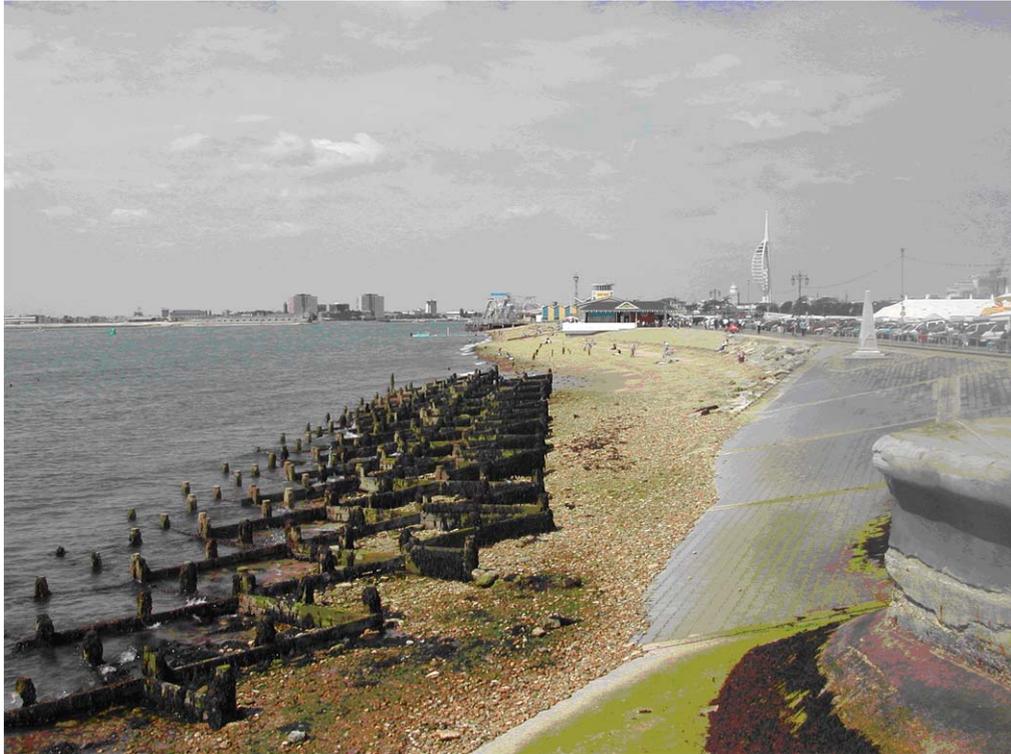
Plate 17 Southsea (2006)

Portsea Island, on which Portsmouth is sited, is heavily developed and the greater part is protected by seawalls (Map 3). Ancient masonry walls at the mouth of Portsmouth Harbour have their toe submerged for most of the tidal cycle. The net littoral drift is in a net westward direction but the volume of material transported is small (Map 2). Further eastwards and extending to Southsea Castle there is a narrow sand and shingle beach, with little contemporary sediment input from alongshore and which therefore has a tendency to erode (Plate 17 and Map 3).

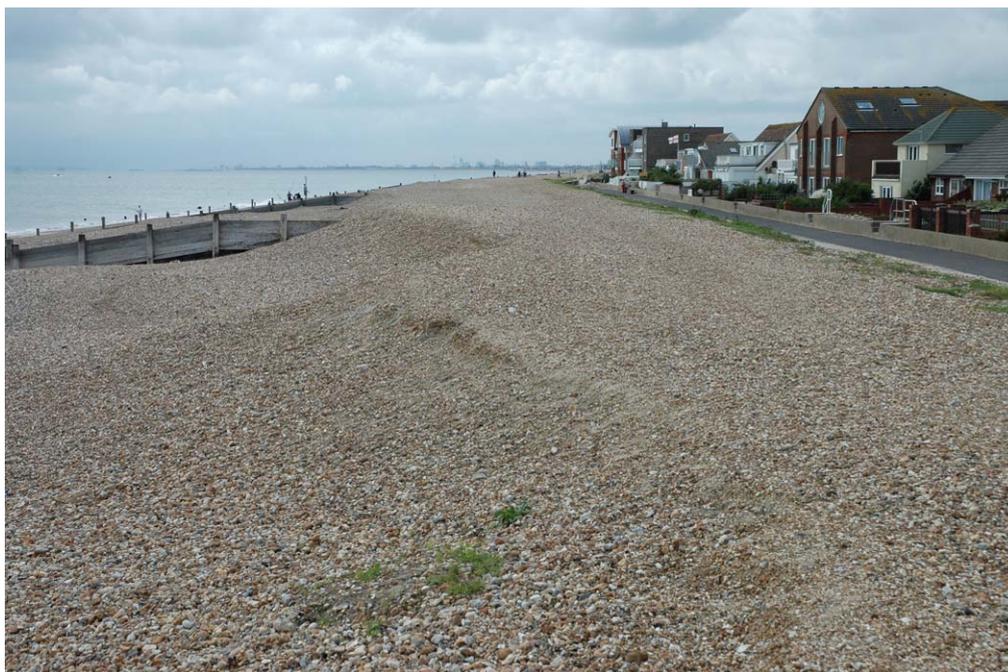
Plate 20 Eastoke beach maintained by recycling (2005)

Whilst the western half of Hayling Island is partly sheltered, the eastern end is exposed to swell wave action from the south-west. The drift divide at Eastoke has also tended to accelerate beach lowering there. It has therefore been necessary to recycle material that is transported eastwards and settles out at Eastoke Point, before it is lost into the mouth of Chichester Harbour. Using regular recycling the Council has been able to retain a substantial beach in front of the Eastoke seawall (compare the typical beach conditions in 2005, as shown in Plate 20, with those in 1985, as shown in Plate 21).

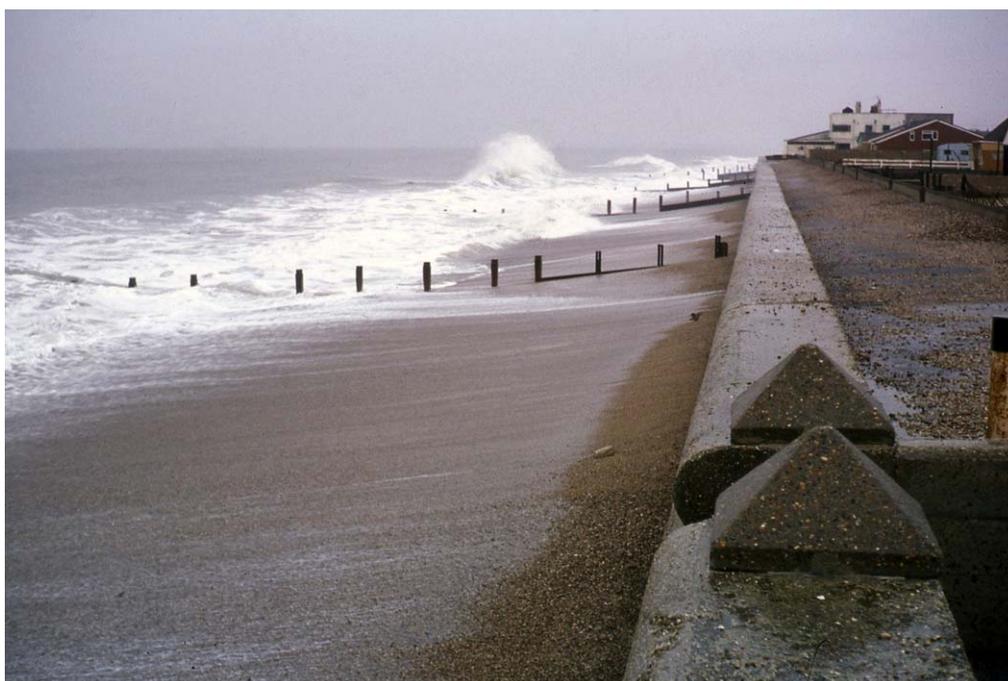
Plate 21 Eastoke beach (1985)

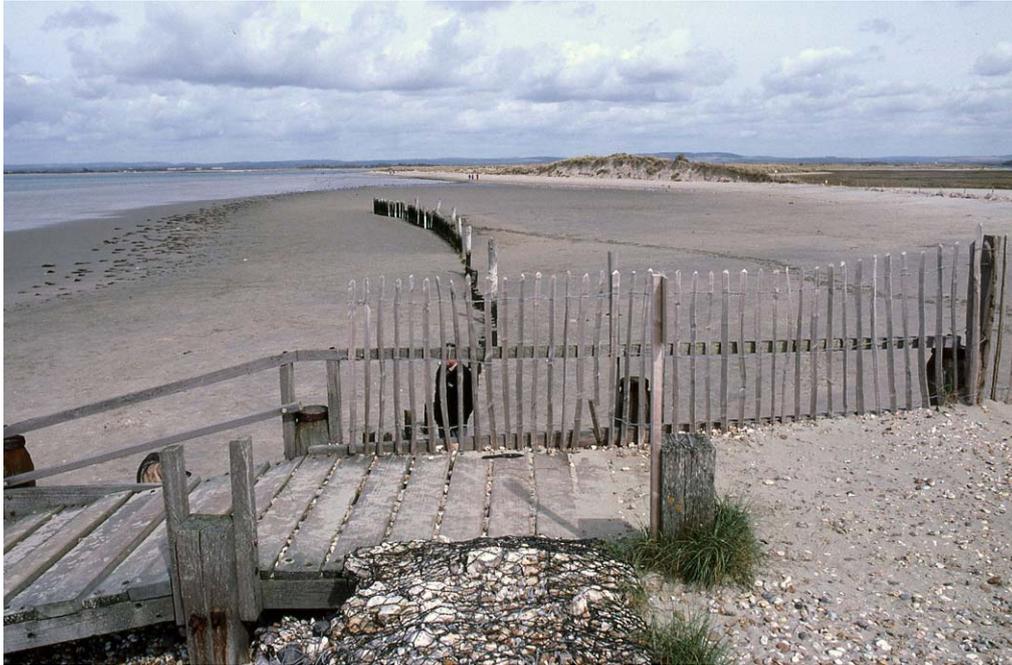
Plate 22 Erosion at East Head (2005)

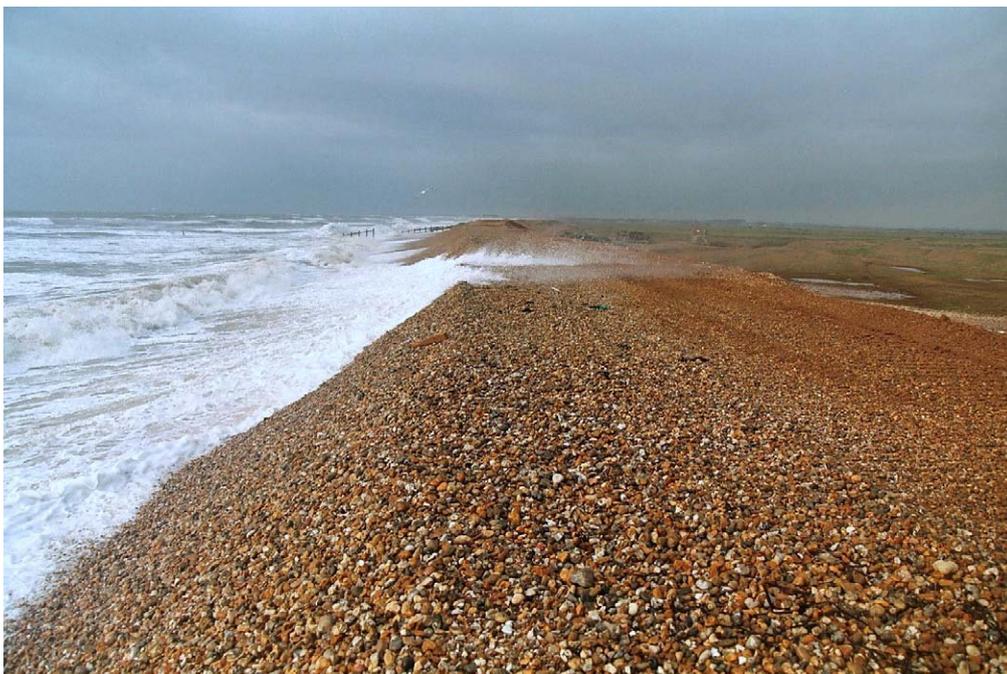
Plate 23 Waves overtopping Medmerry beach (2002)

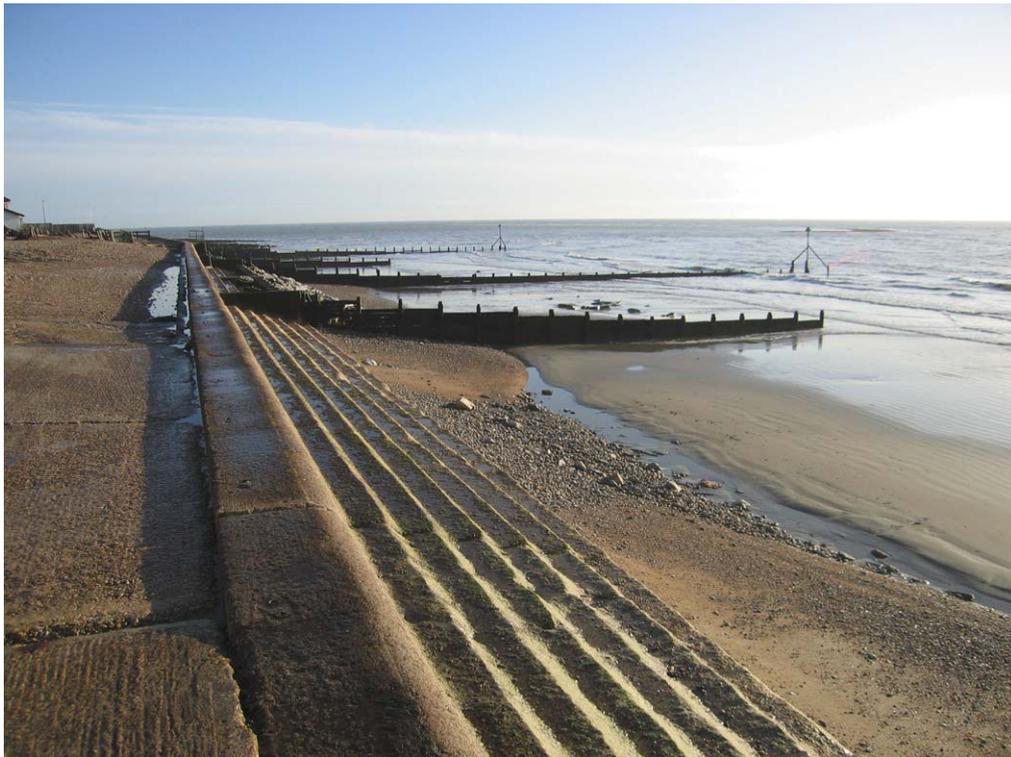
Plate 24 Selsey West Beach (2006)

There is a continuous line of seawalls from just east of Medmerry to Selsey Bill itself. This frontage once had a pebble beach overlying the sandy lower foreshore. As can be seen in Plate 24, upper beach levels have fallen and the seawalls are now exposed to heavy wave action at high tide. This has led to wall failure in the recent past. The area is also a drift divide, so that beach lowering is inevitable during times when there is no onshore shingle supply.

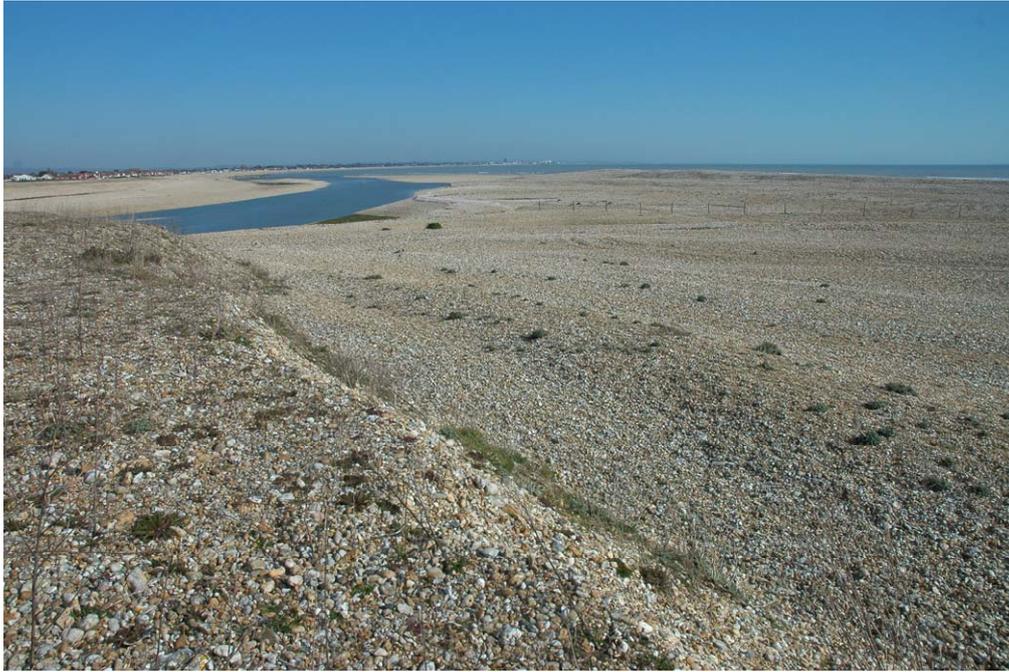
Plate 25 Shingle accretion off Pagham Harbour (2007)

From East Beach to the entrance to Pagham Harbour there is a sand and shingle spit, which has required nourishment and recycling to maintain it. At present the shingle spit is fronted by a massive accumulation of shingle transported landwards from the Inner Owers. The accumulation is so large that littoral drift has caused the entrance channel to Pagham Harbour to be deflected north-eastwards (Plate 25). However, when the present accumulation becomes dispersed, the spit may require maintenance to prevent it from being breached.

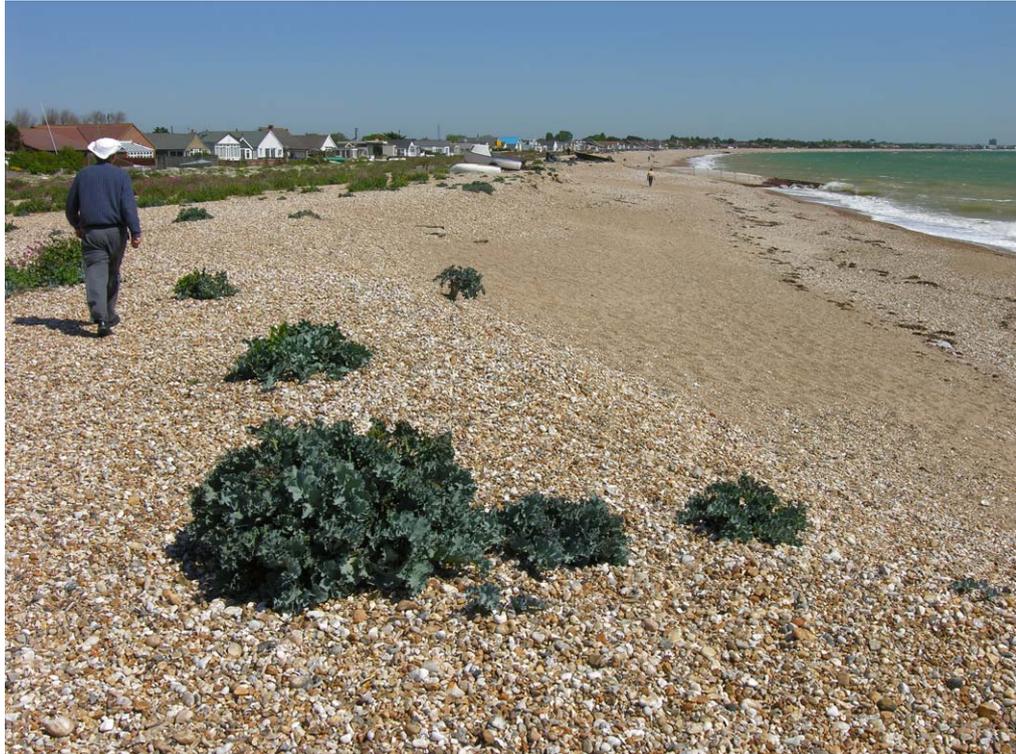
Plate 27 Recent erosion at Pagham Beach Estate (May 2007)

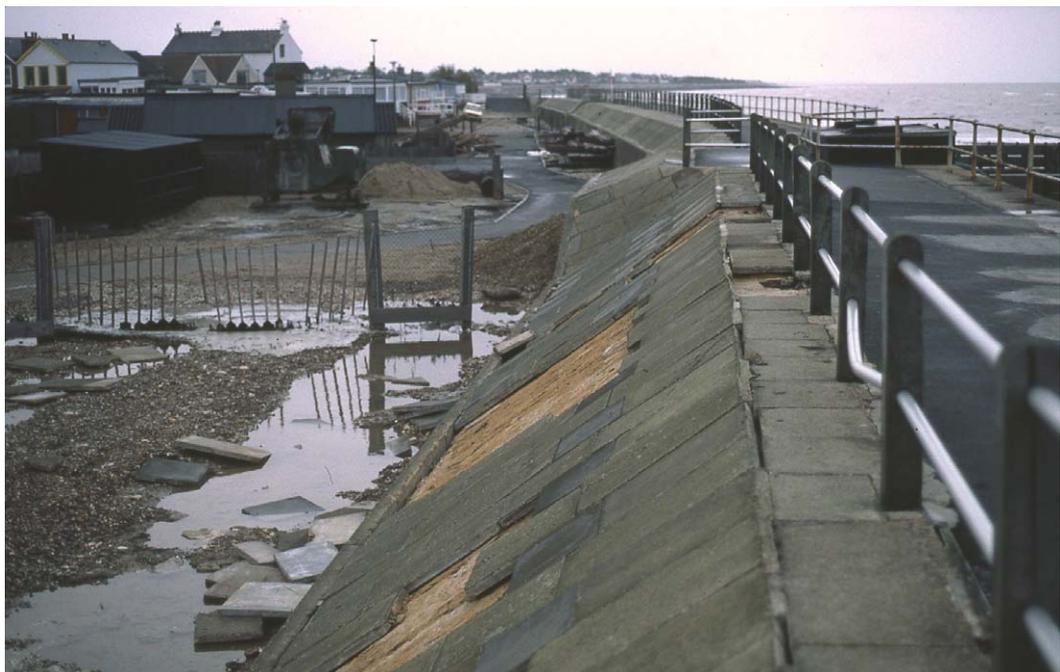
Plate 28 Wave damage at Aldingbourne Rife (1984)

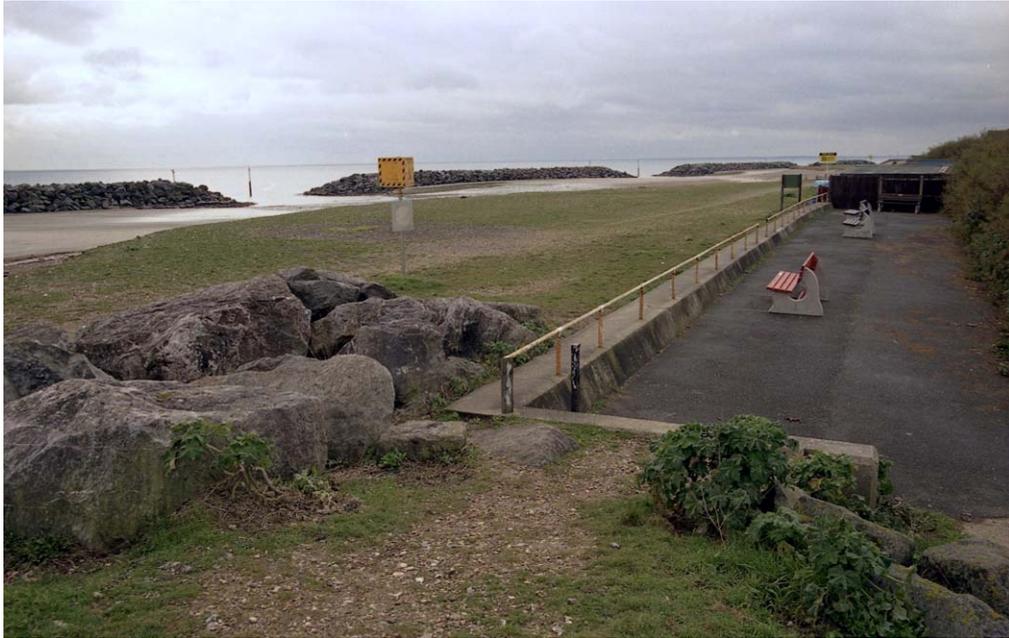
Plate 29 Elmer breakwaters (2005)

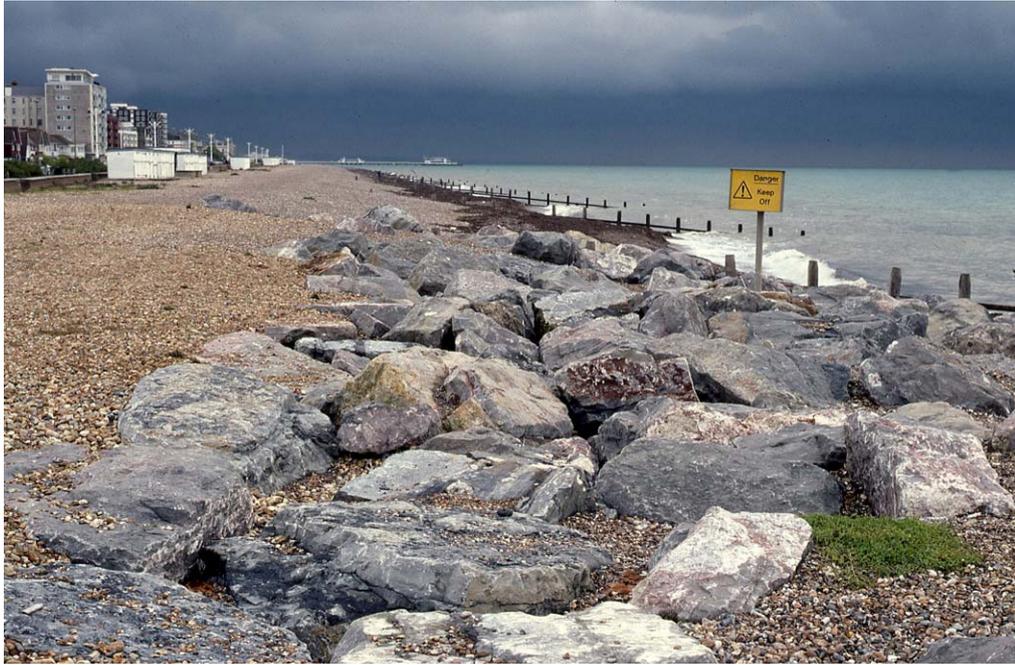
Plate 30 Beach armoured with rock at Worthing (1997)

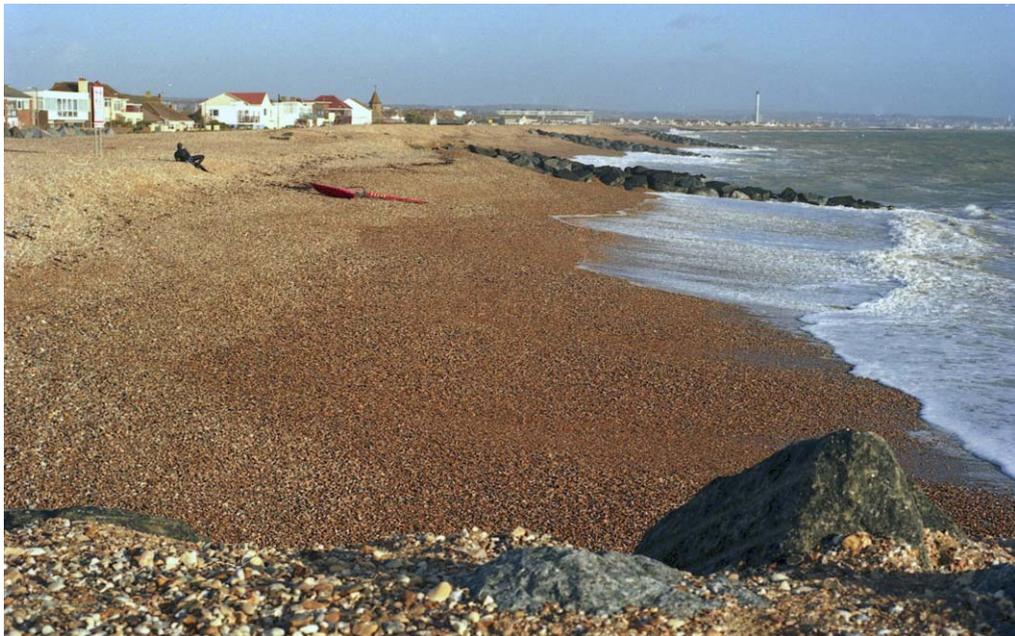
Plate 31 Nourished beach at South Lancing (2005)

To the east of Worthing at Brooklands the coast road runs very close to the shore and this is an area that is vulnerable to flooding. Further eastward to Lancing there is a barrier beach and at the Widewater Lagoon there is housing that would be flooded if the shingle barrier beach was breached. This frontage has therefore been nourished on two occasions and rock groynes have replaced the timber ones in the recent past (Plate 31). The short length of seawall opposite the Widewater Lagoon is now fronted by a wide pebble ridge.

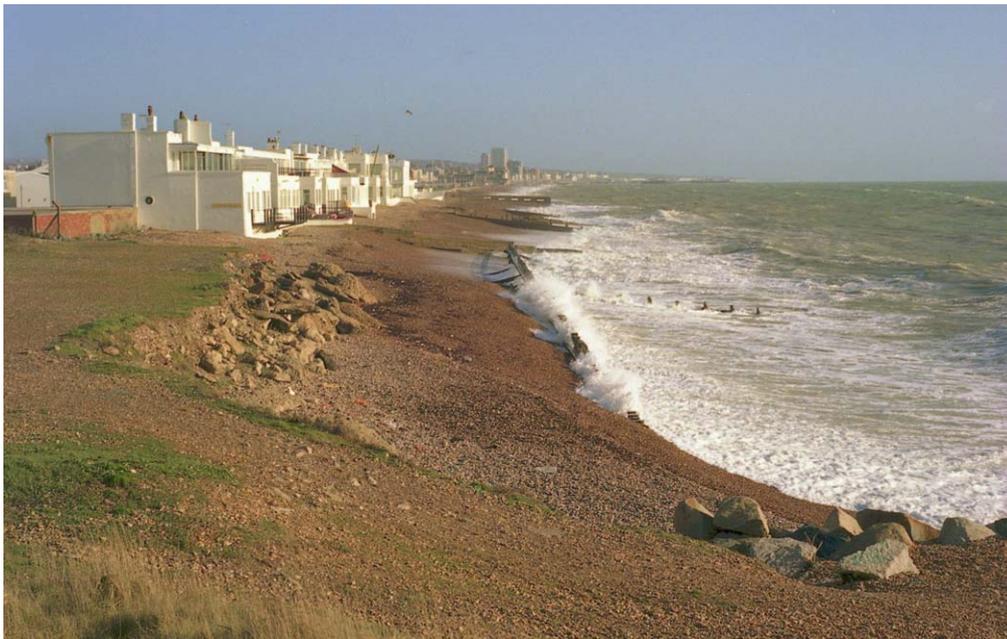
Plate 32 Portslade-by-Sea (2005)

The East Beach is now protected by a sloping revetment of concrete armour units, whilst further eastward there are sheet piled walls and old timber revetments. At Portslade the defences are piecemeal and there are several shorefront properties at risk of wave damage (Plate 32).
