Anglian Offshore Dredging Association

Marine Aggregate Regional Environmental Assessment: Coastal Characterisation

Technical Note TN-DDR4472-02

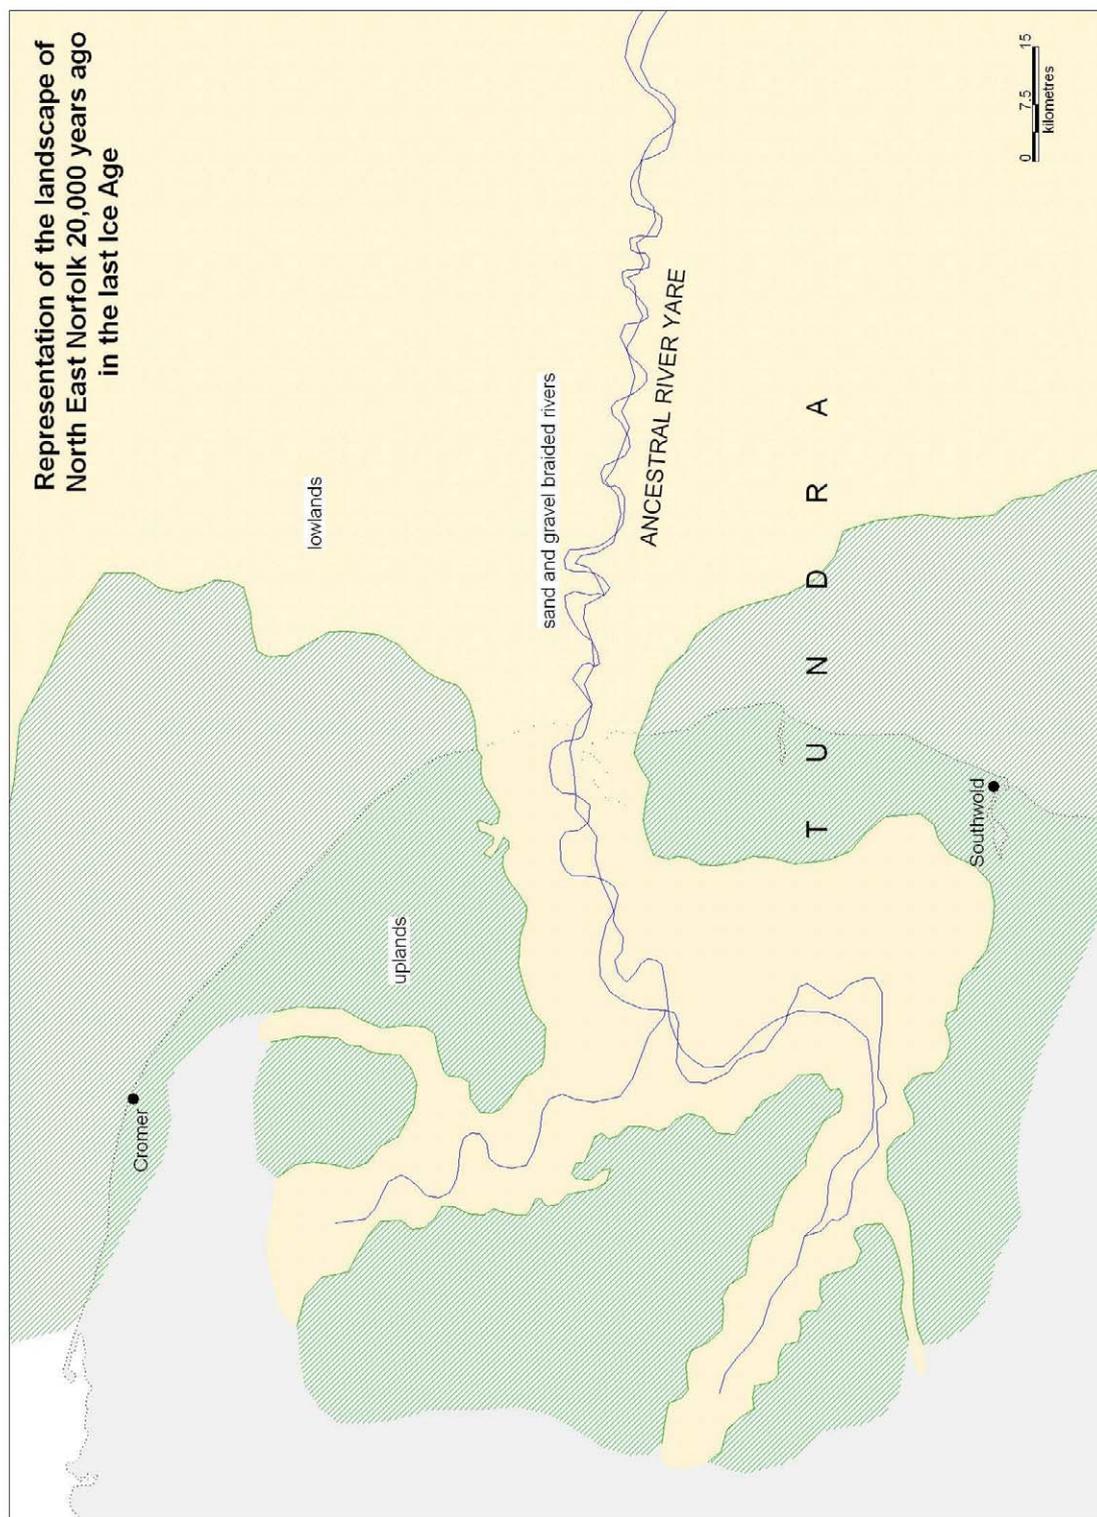
Figure 2.1 Simplified interpretation of eastern Norfolk and its nearshore seabed towards the end of the last glaciation, i.e. about 20,000 years ago

It is useful to first summarise the formation and subsequent changes of this coastline since the end of the last Ice Age. Figure 2.1 shows a simplified interpretation of a possible historical morphology of part of the study area towards the end of the last glaciation, i.e. about 20,000 years ago. This landscape has been interpreted by the aggregate dredging industry from seabed contours and sub-surface geophysical profiles (Bellamy, A. G., *pers. comm.*, 2010). Melt-water from the ice-sheets to the west and north would have fed much larger rivers than found in the UK today. In addition spring thaw of winter snow and permafrost in the periglacial environment existing in East Anglia and the North Sea (akin to present-day arctic Canada) would have produced significant seasonal river flows. These flows would have carried very large quantities of sand and gravel downstream and, as the floods subsided, deposited them over broad floodplains.

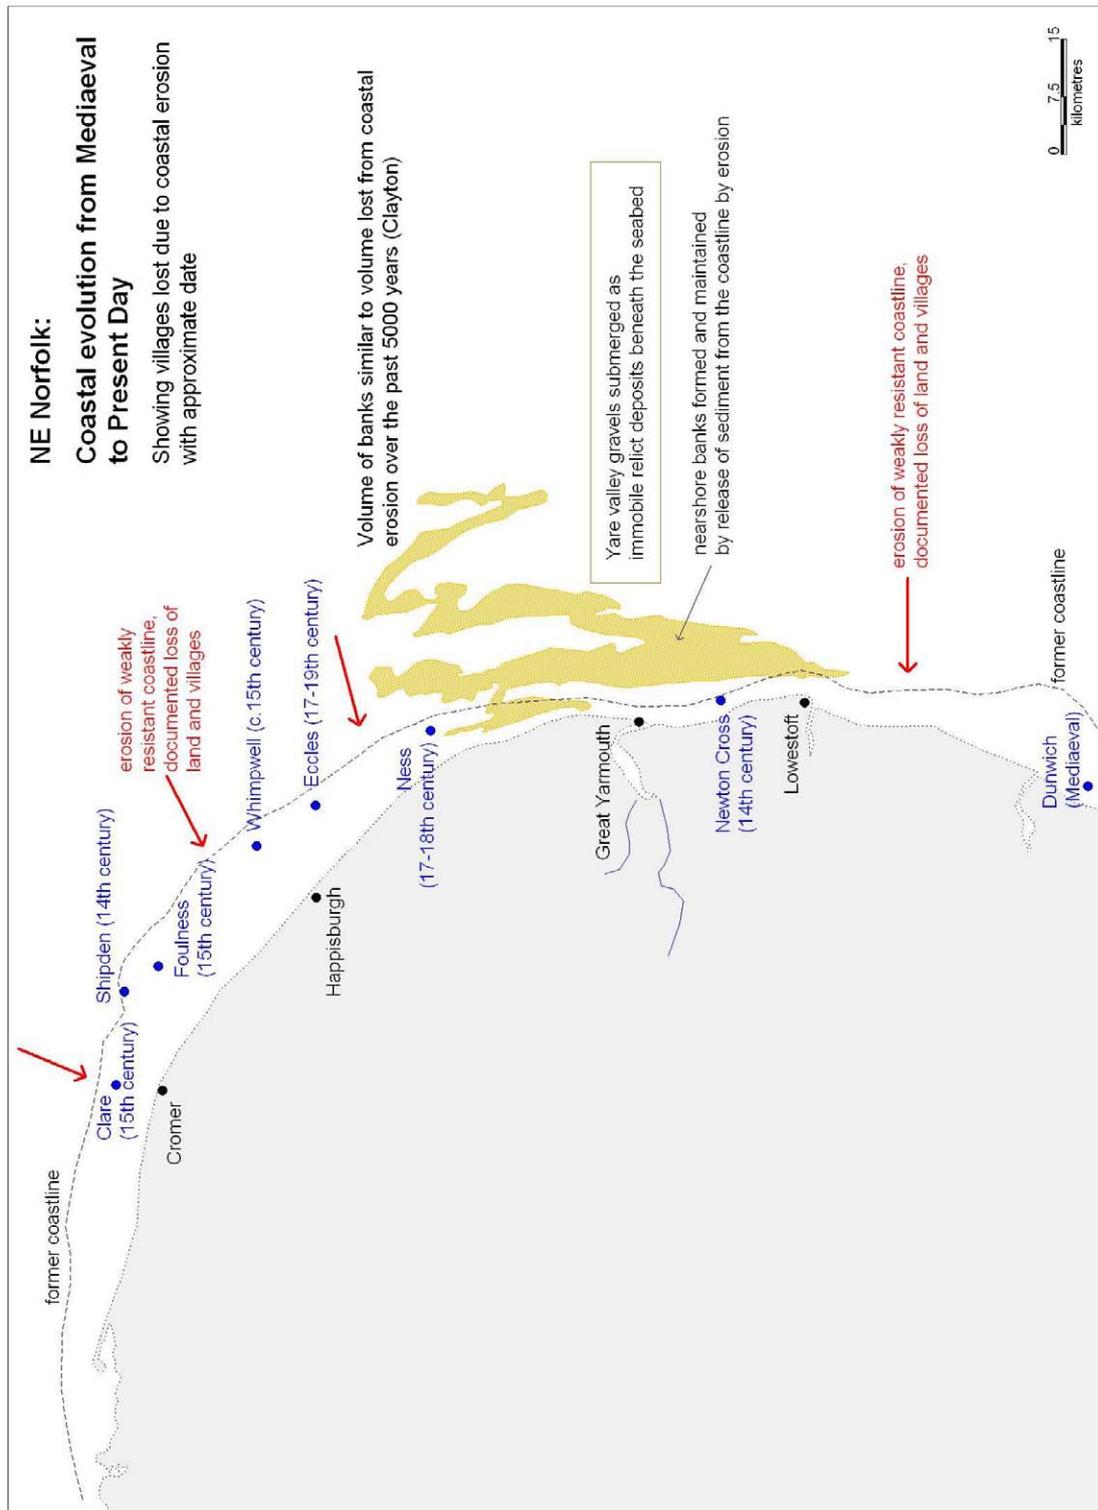
Figure 2.7 Historic coastal changes along the shoreline between Cromer and Great Yarmouth

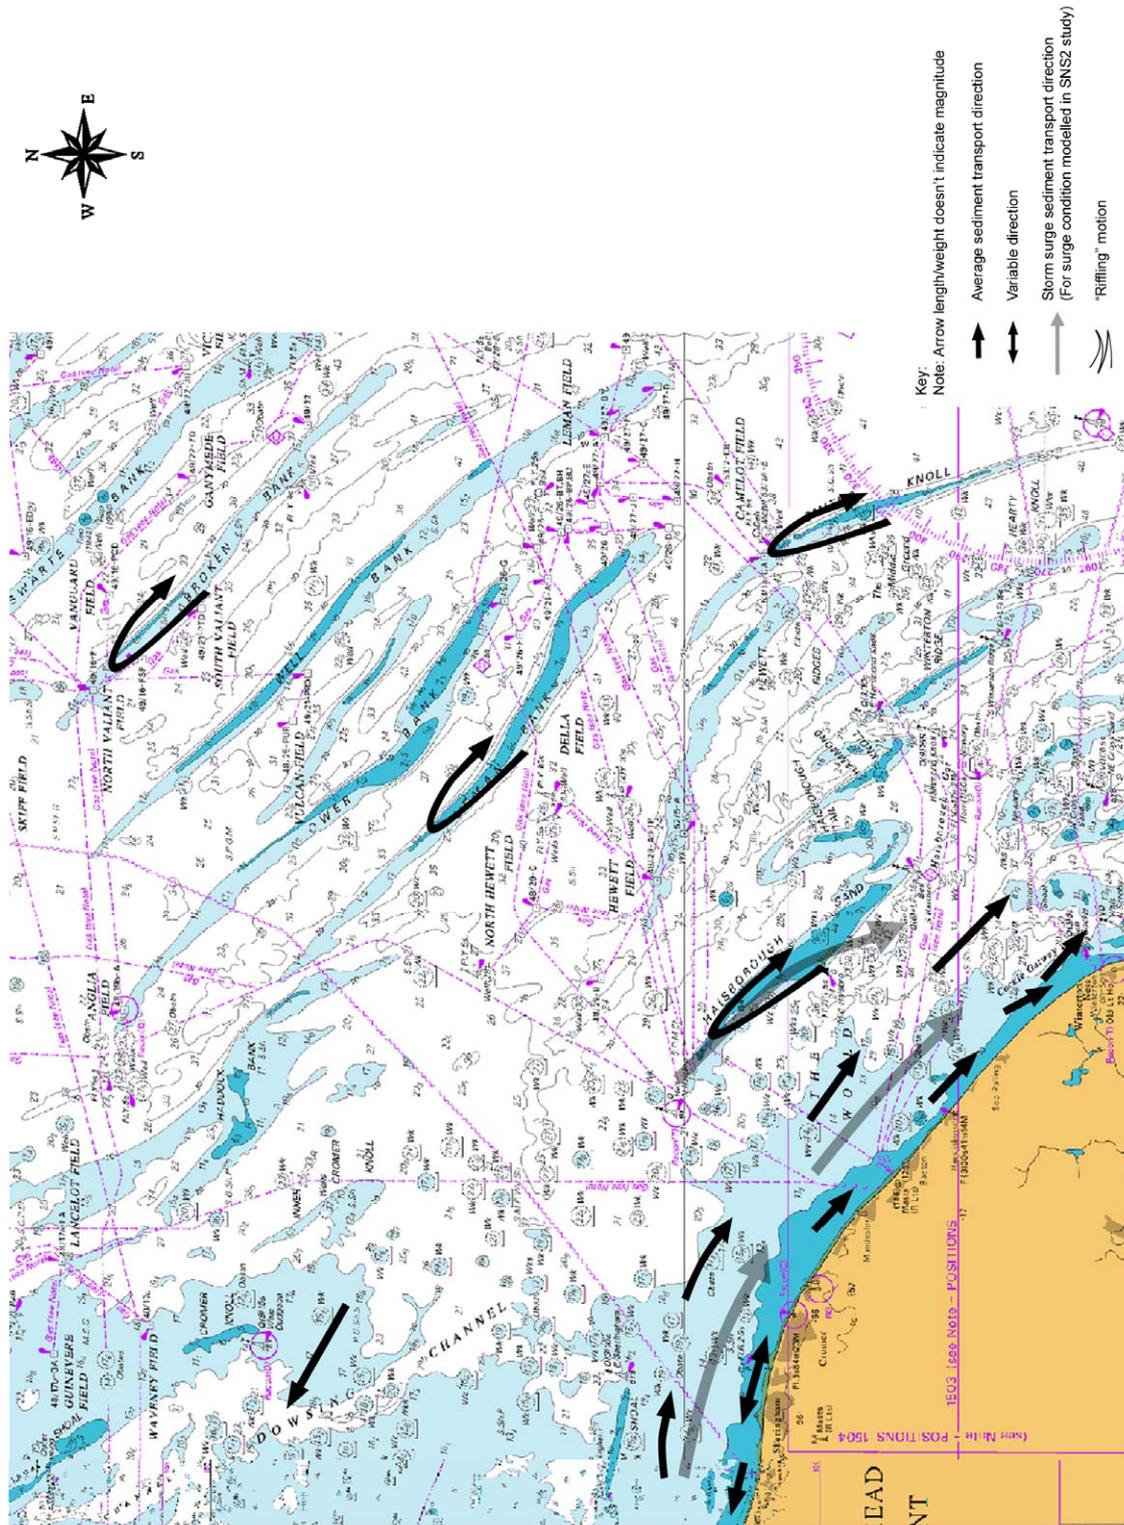
Figure 3.1 North Norfolk schematic sediment transport pathways

Figure 3.1 shows the evidence for sediment transport over the nearshore seabed for this part of the coastline that was compiled during the SNS2 study using analysis of seabed features such as sand waves and using numerical modelling under a variety of different tidal conditions.

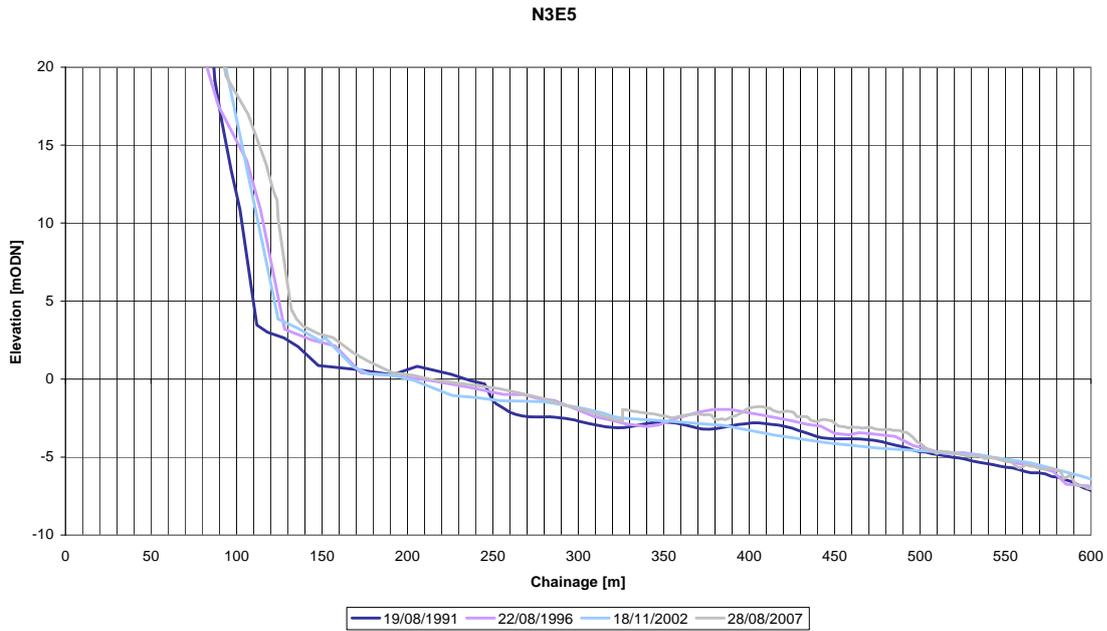
Figure 3.2 Landward part of Profile N3E5: Cromer

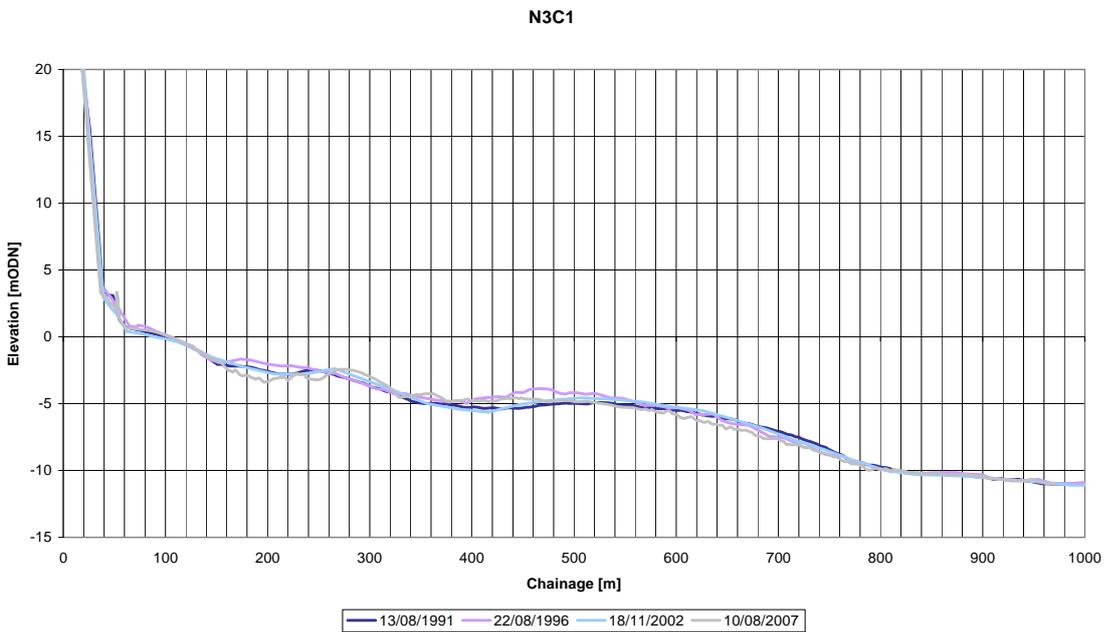
Figure 3.3 Landward part of Profile N3C1: Mundesley

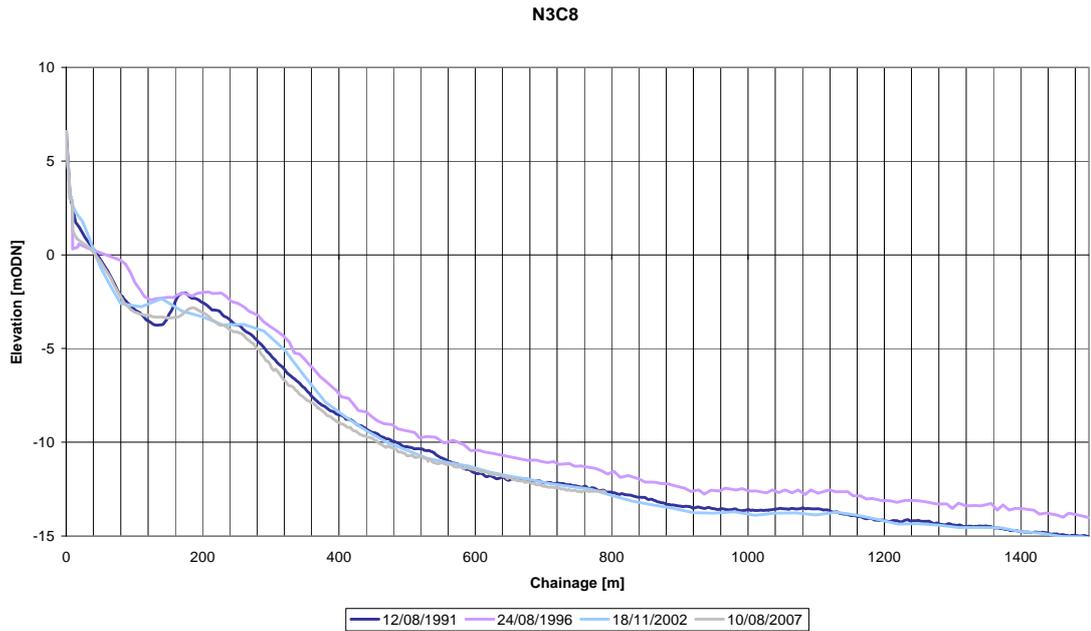
Figure 3.4 Landward part of Profile N3C8: Keswick

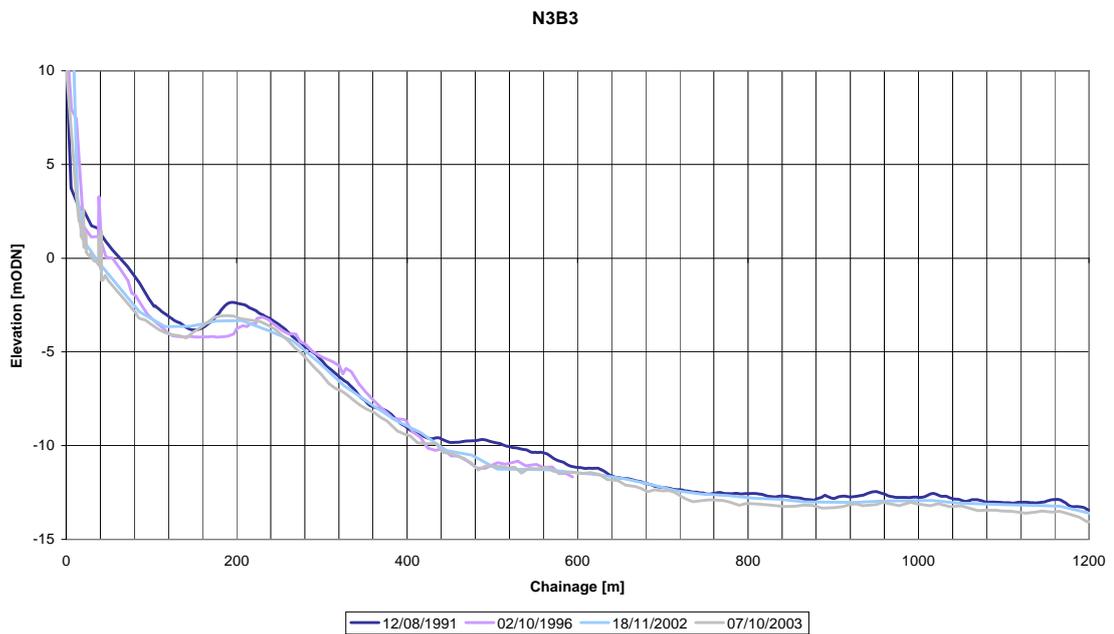
Figure 3.5 Landward part of Profile N3B3: Walcott

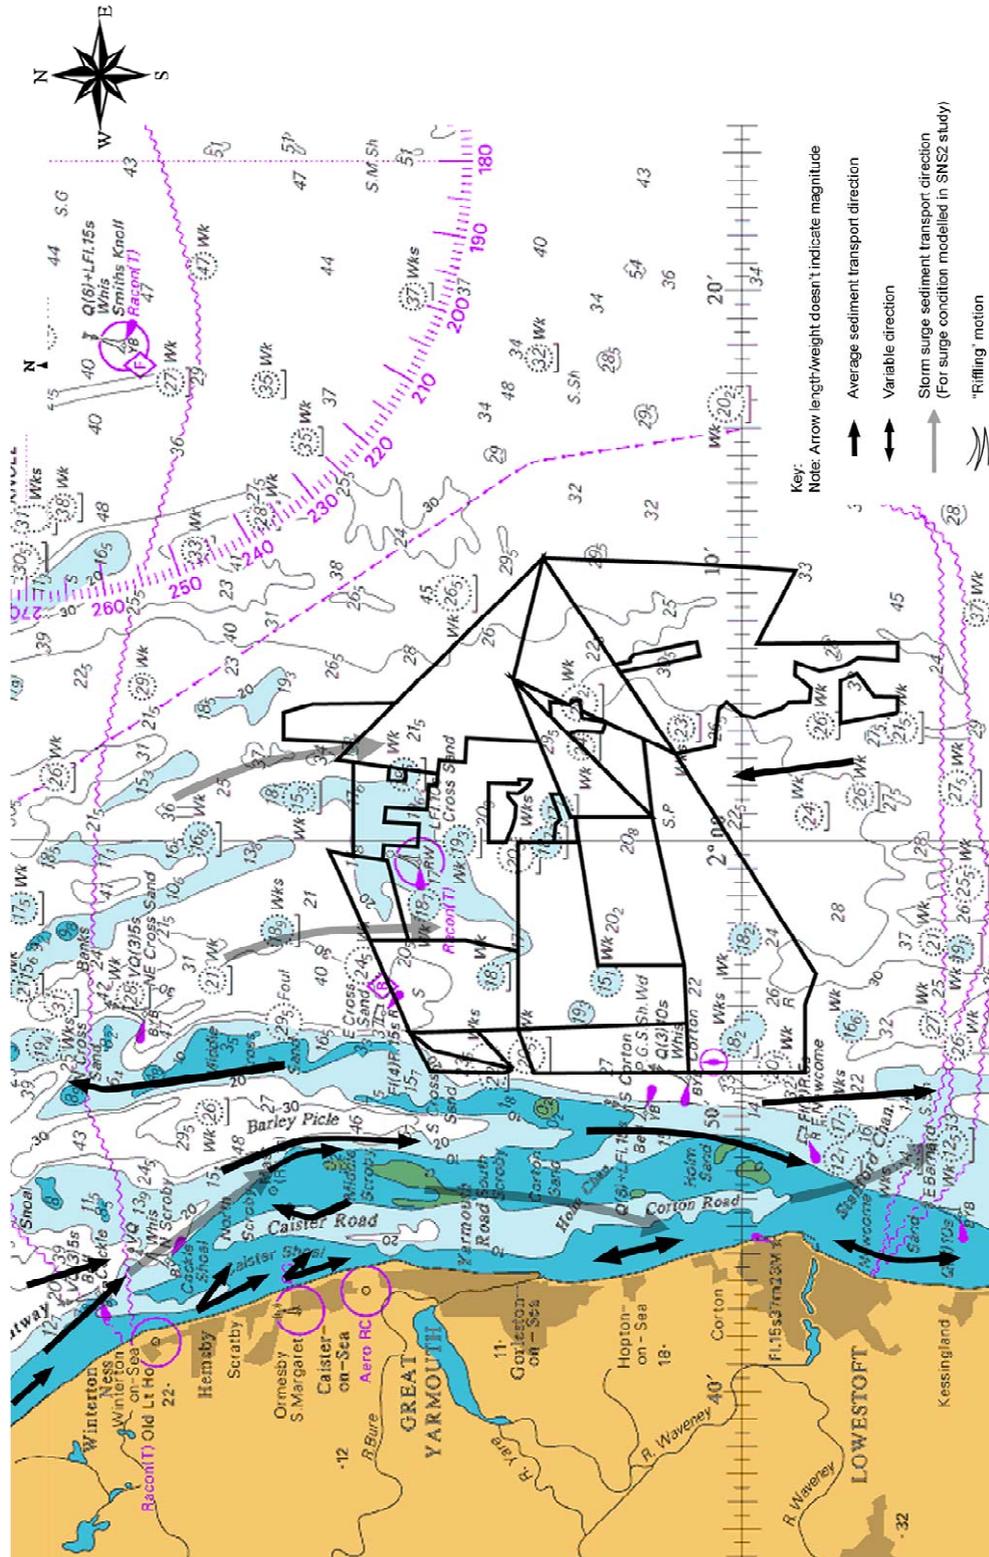
Figure 3.6 East Norfolk and North Suffolk schematic sediment transport pathways

The pattern of sediment flow is such that while being relatively shore parallel over much of the coast it tends to set against the coast closer to Winterton Ness. Figure 3.6 shows the evidence for sediment transport over the nearshore seabed for this part of the coastline that was compiled during the SNS2 study using analysis of seabed features such as sand waves and using numerical modelling under a variety of different tidal conditions.

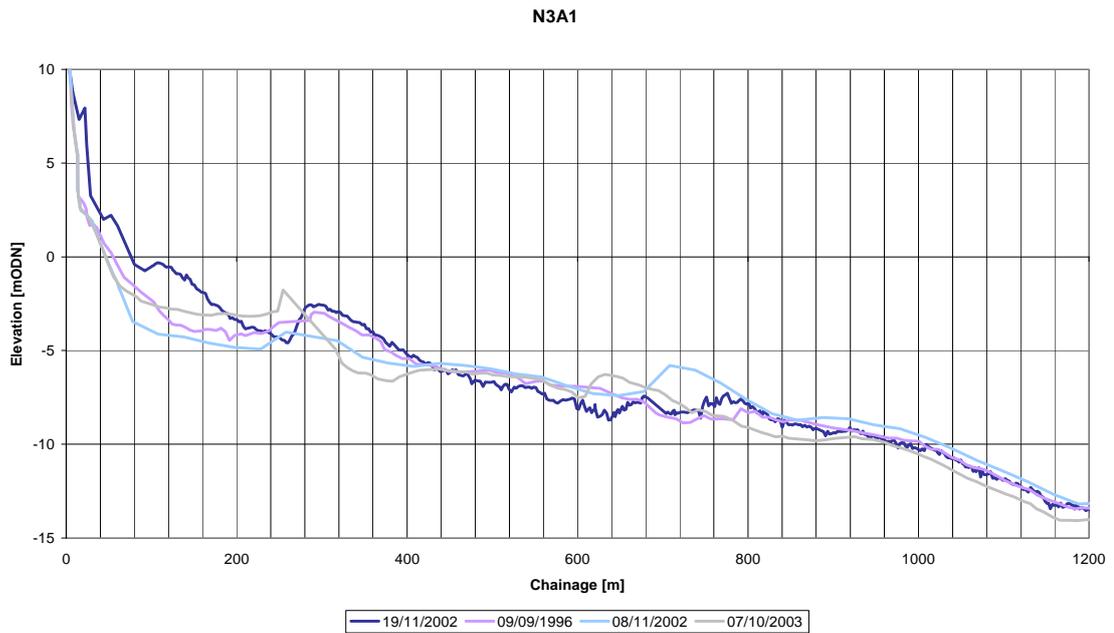
Figure 3.7 Landward part of profile N3A1: Sea Palling

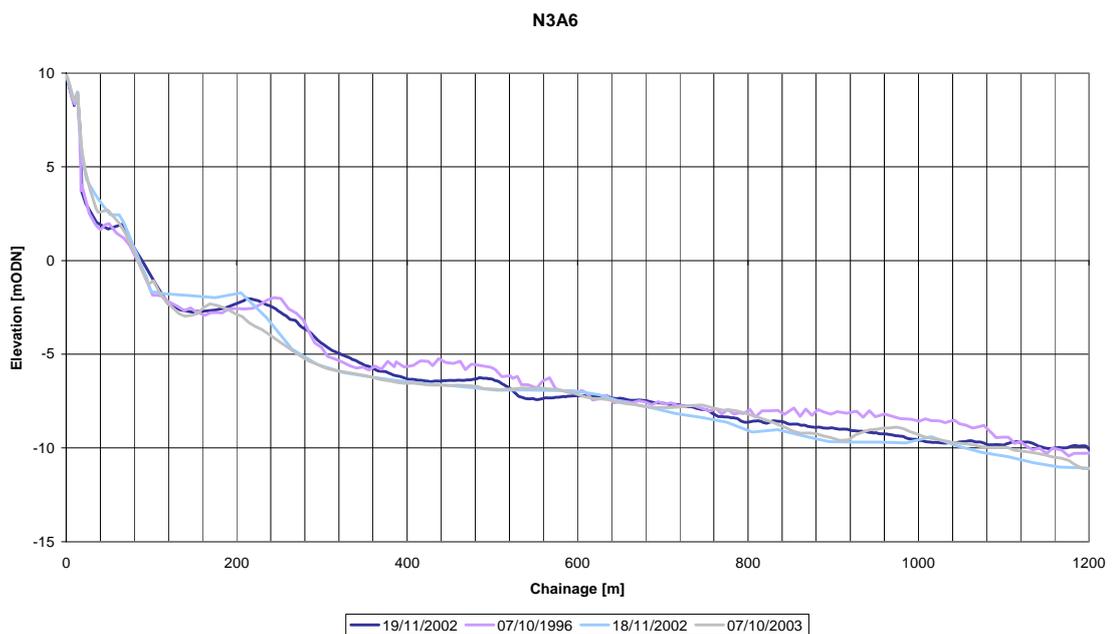
Figure 3.8 Landward part of profile N3A6: Horsey

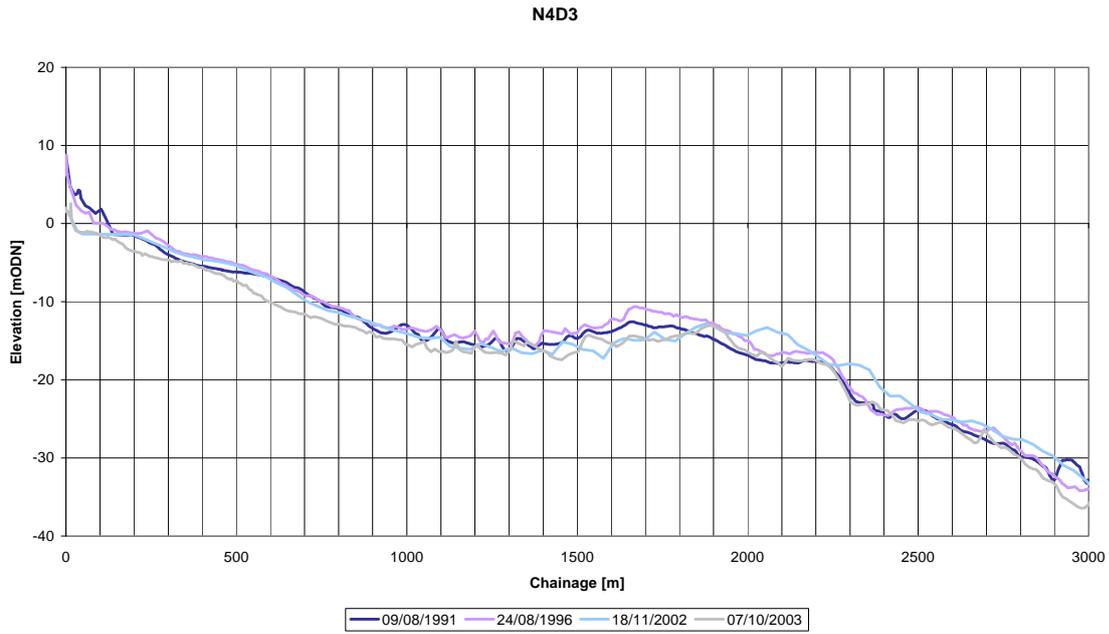
Figure 3.9 Profile N4D3: Winterton-on-Sea

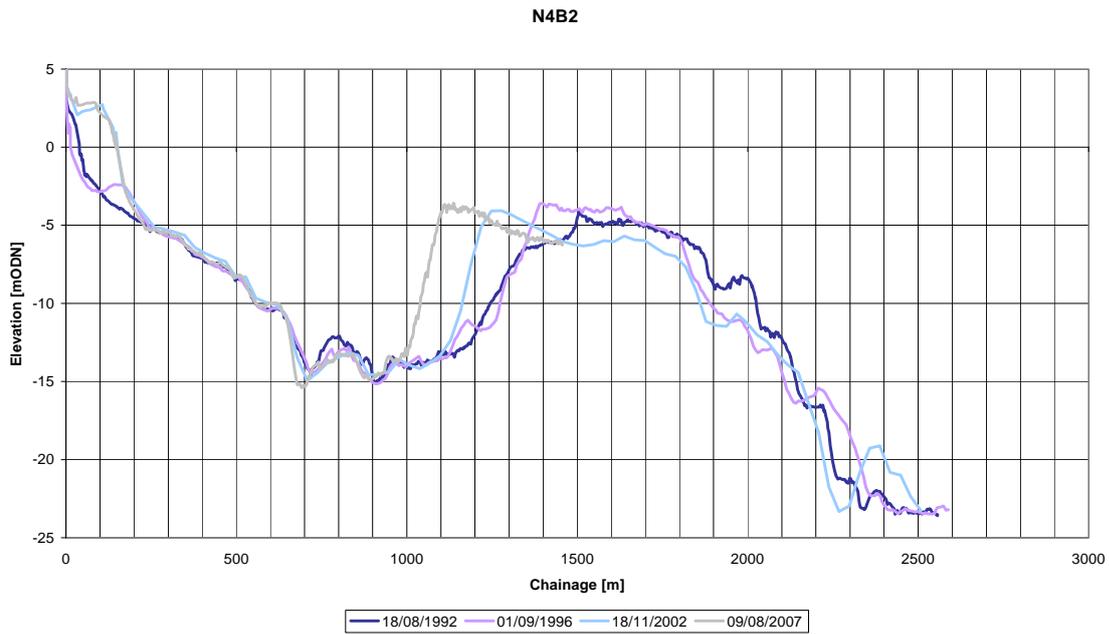
Figure 3.10 Profile N4B2: North Caister-on-Sea

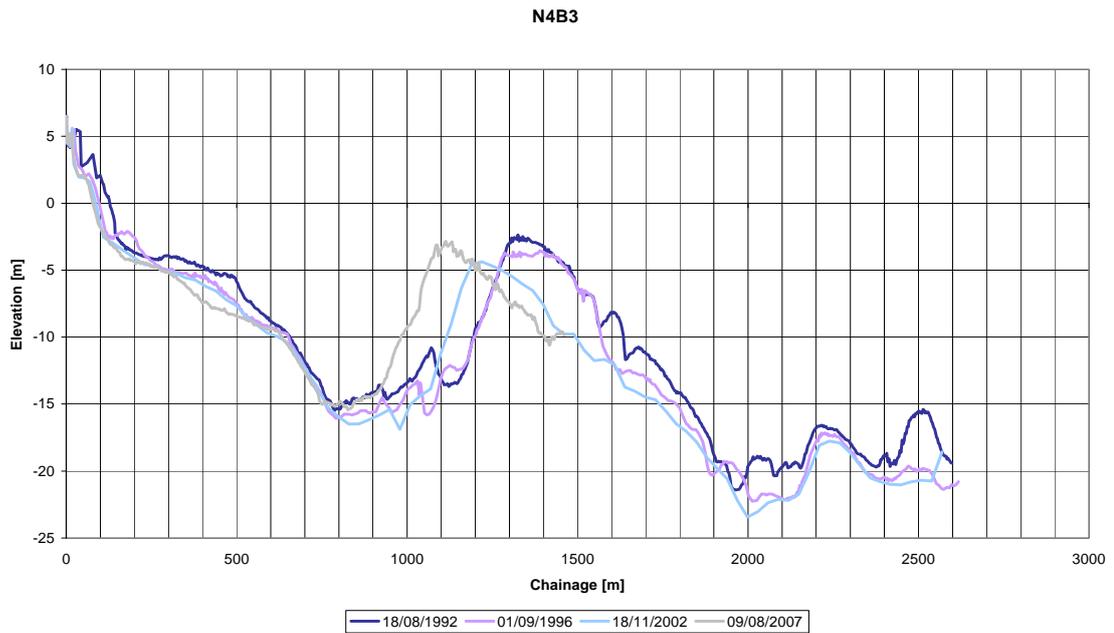
Figure 3.11 Profile N4B3:Caister-on-Sea

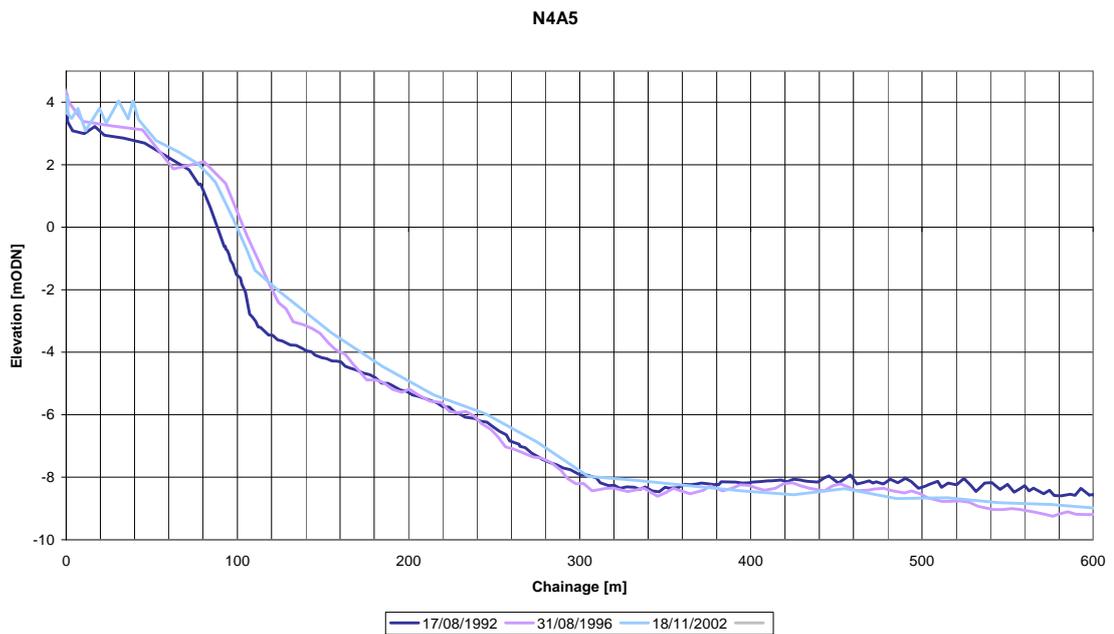
Figure 3.12 Profile N4A5: Great Yarmouth

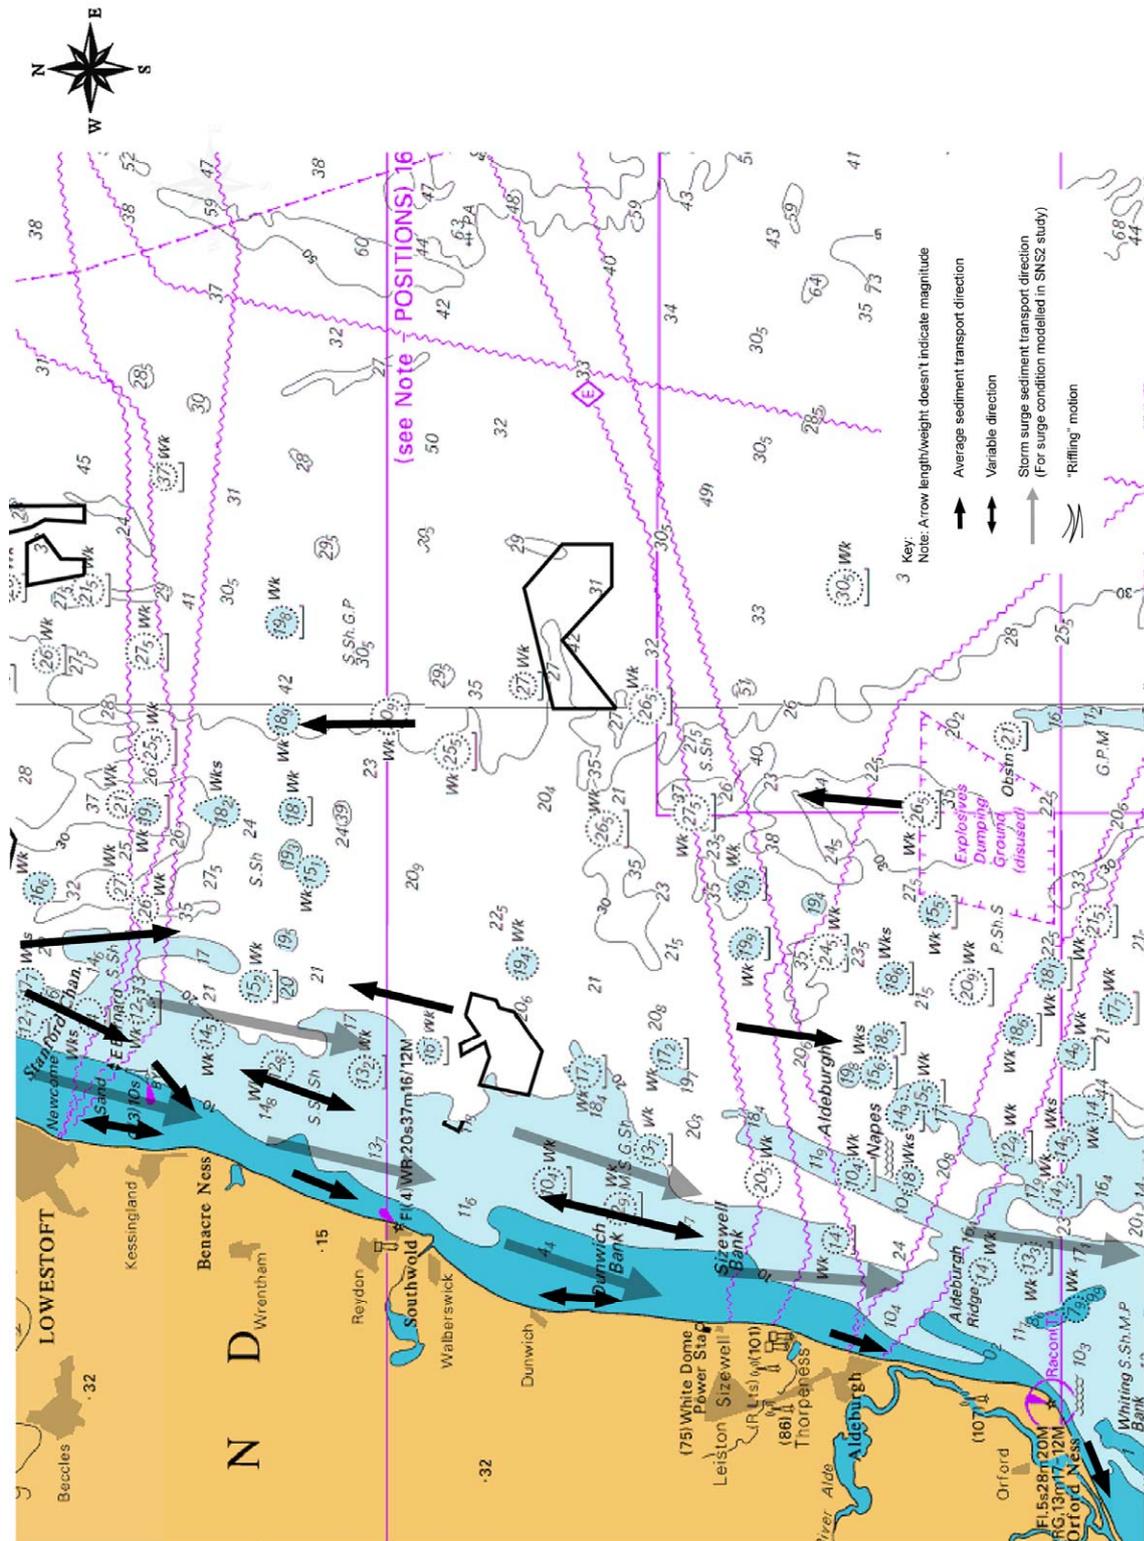
Figure 3.13 North Suffolk schematic sediment transport pathways

Figure 3.13 shows the evidence for sediment transport over the nearshore seabed for this part of the coastline compiled during the SNS2 study using both an analysis of seabed features such as sand waves and using numerical modelling under a variety of different tidal conditions. This figure can be interpreted, from the viewpoint of beach evolution, as suggesting an onshore transport of sediment (mainly sand) from the nearshore bank system to the beaches just south of Lowestoft Harbour and again to the coastline just south of Kessingland/ Benacre Ness.

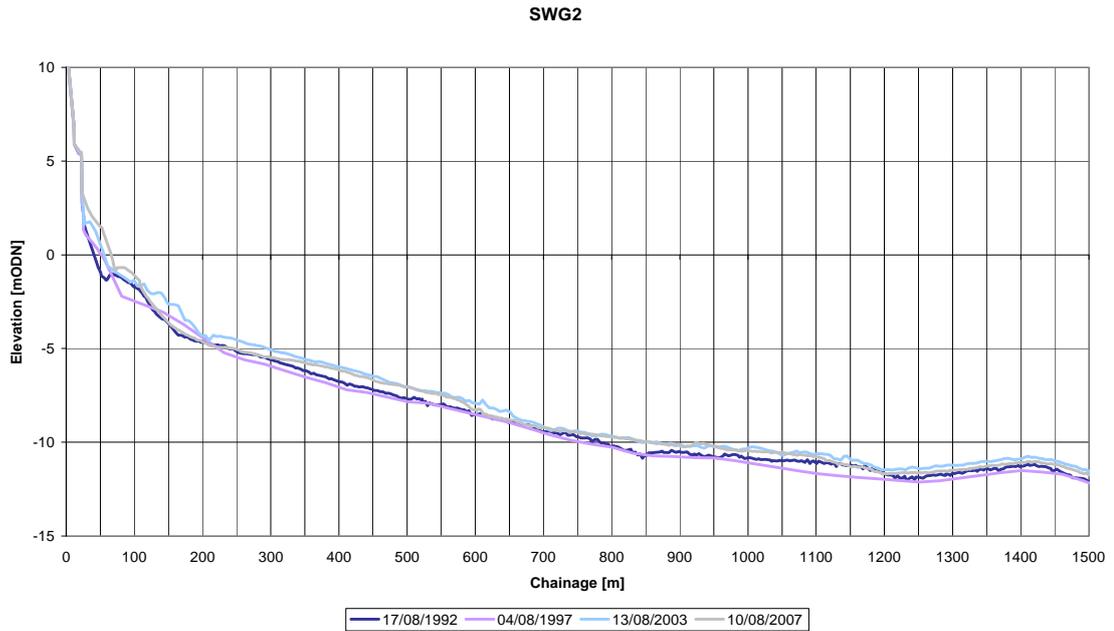
Figure 3.14 Profile SWG2: Gorleston-on-Sea

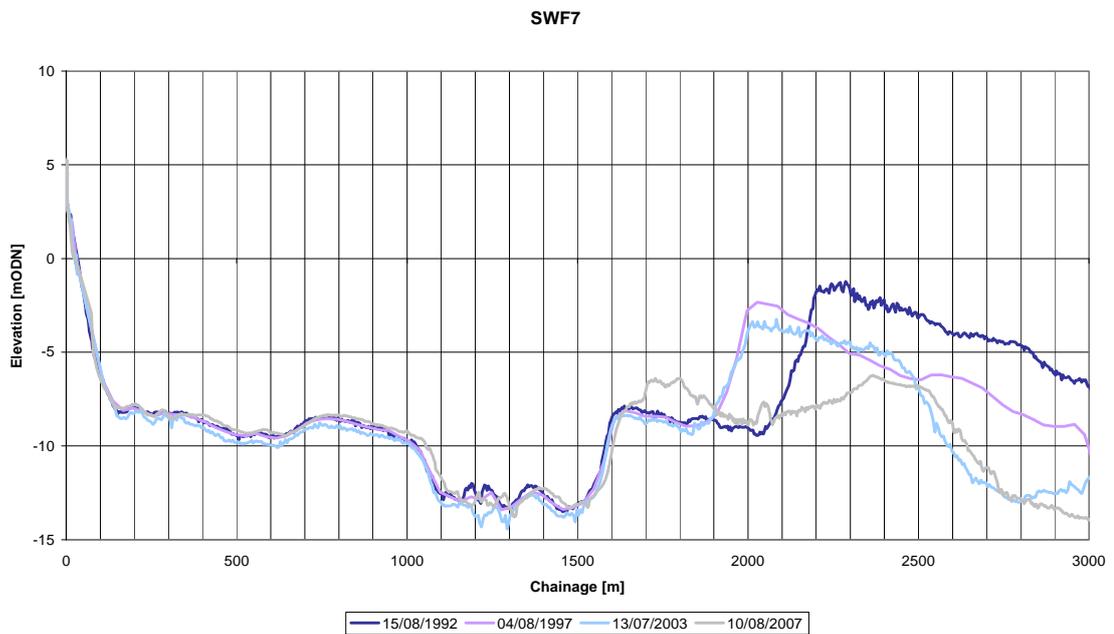
Figure 3.15 Profile SWF7:Lowestoft

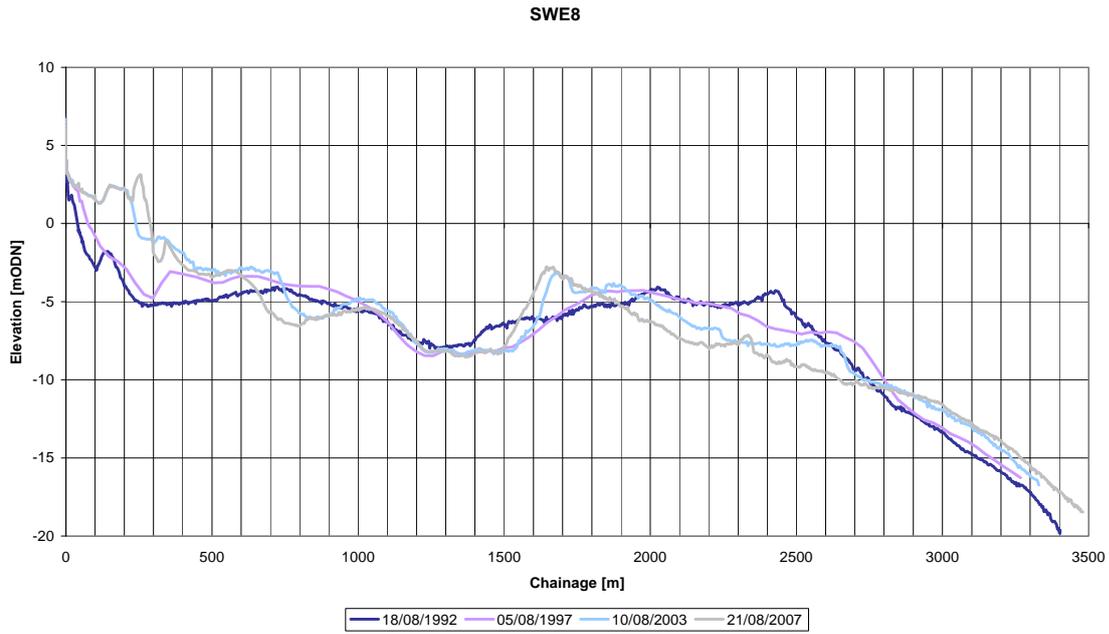
Figure 3.16 Profile SWE8: Kessingland

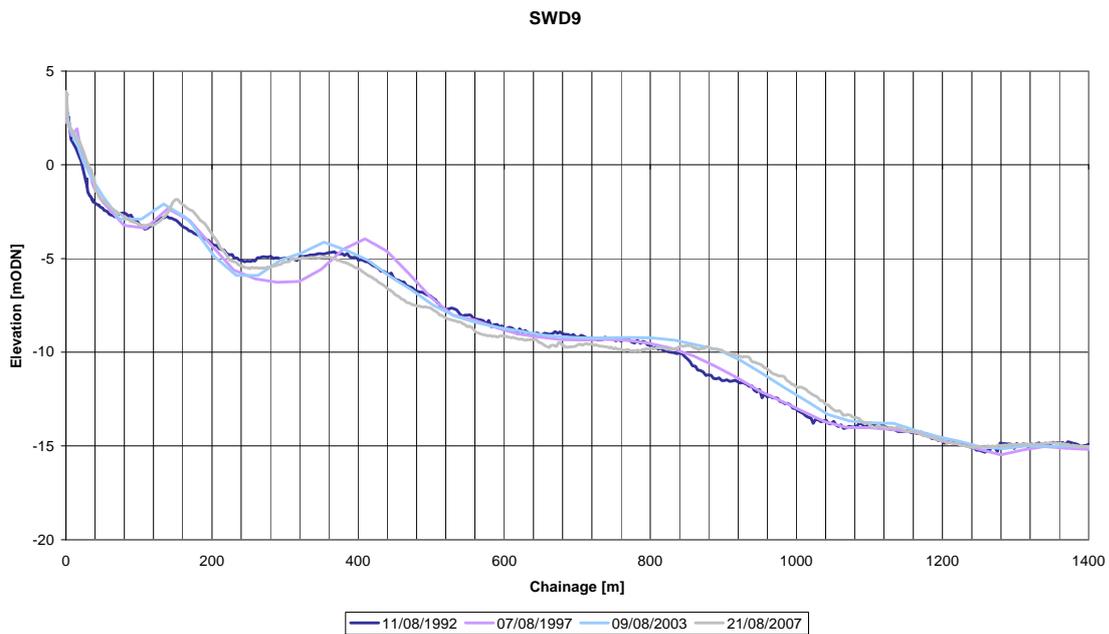
Figure 3.17 Profile SWD9: Southwold

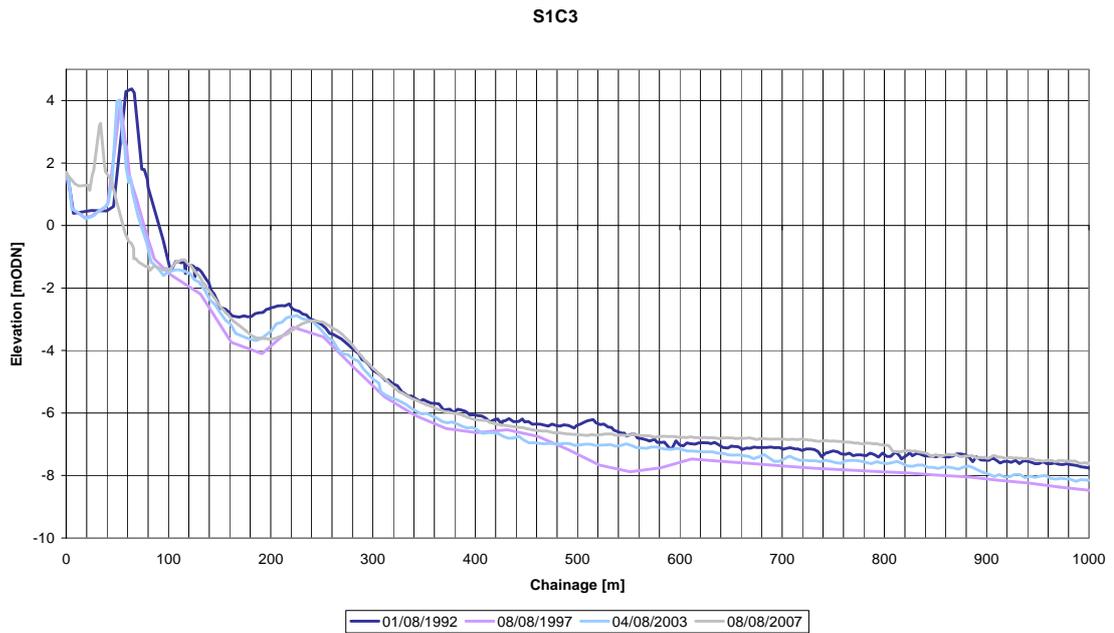
Figure 3.18 Profile S1C3: Alberswick

At Walberswick, the surveys along Profile S1C3 (see Figure 3.18) show the landward retreat and lowering of the shingle barrier beach crest which was over-washed and damaged further in a storm in November 2007, soon after the latest of the surveys shown. There is either a break in the steep slope of the shingle beach, or an indistinct trough at about -1m OD before the beach slopes down again into a more persistent trough about 180m offshore. There is a small bar beyond this trough, and from its crest the profile slope gradually decreases so that by between 500m and 700m offshore it is virtually horizontal. Here, at a depth of between -6.5m and -7.5m there is no clear sign of variations in level other than those expected as a result of survey inaccuracies, and the beach toe here is therefore concluded to be no deeper than about -7.5m OD.

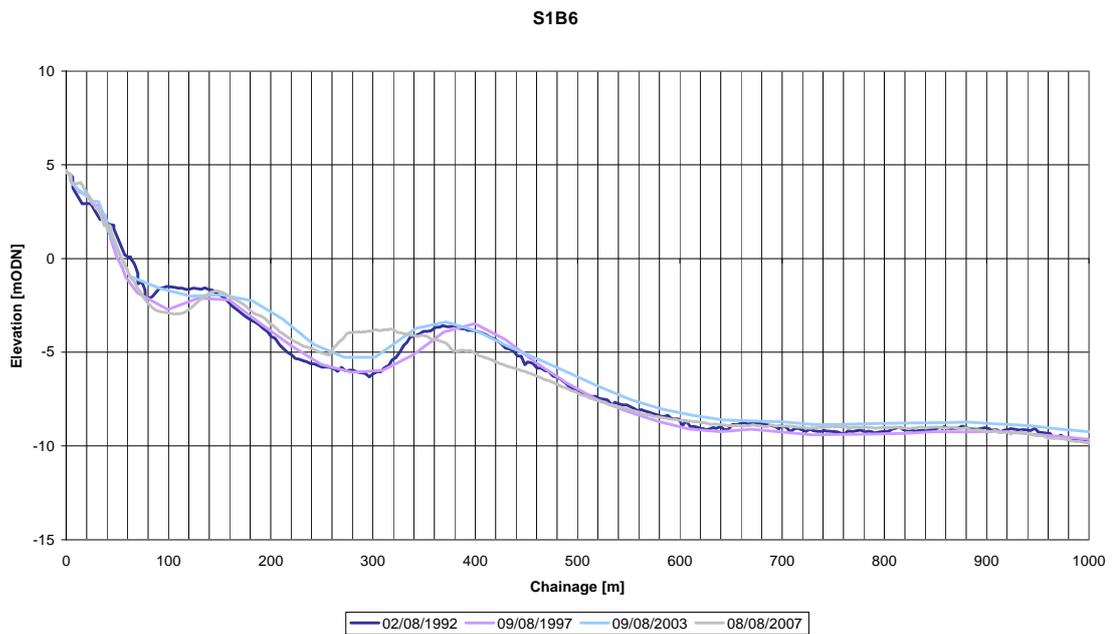
Figure 3.19 Profile S1B6: Sizewell

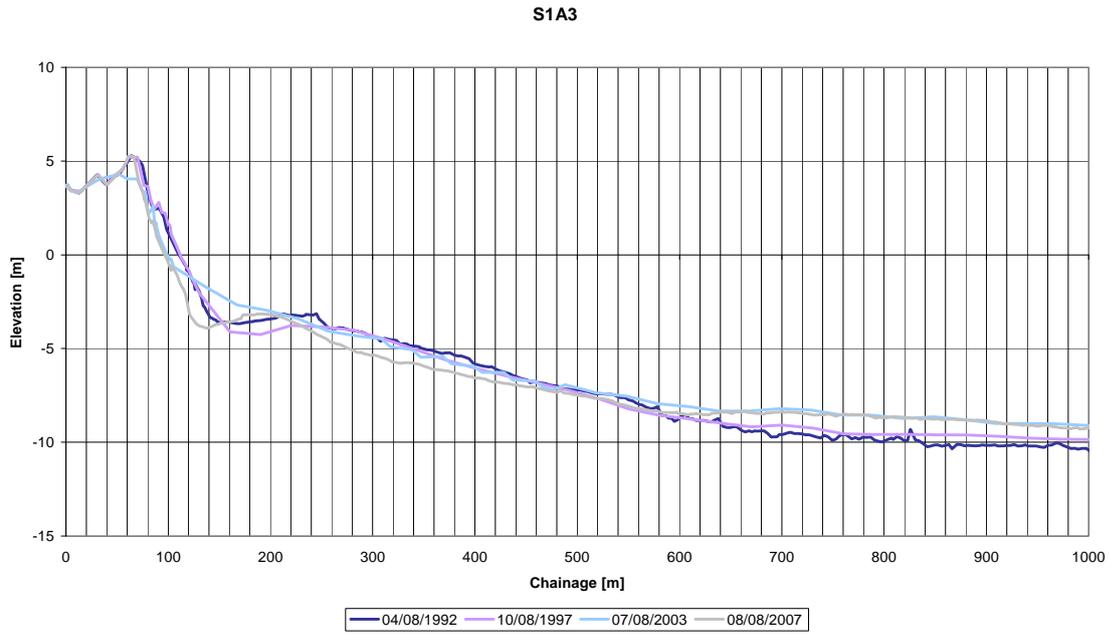
Figure 3.20 Profile S1A3: Thorpeness

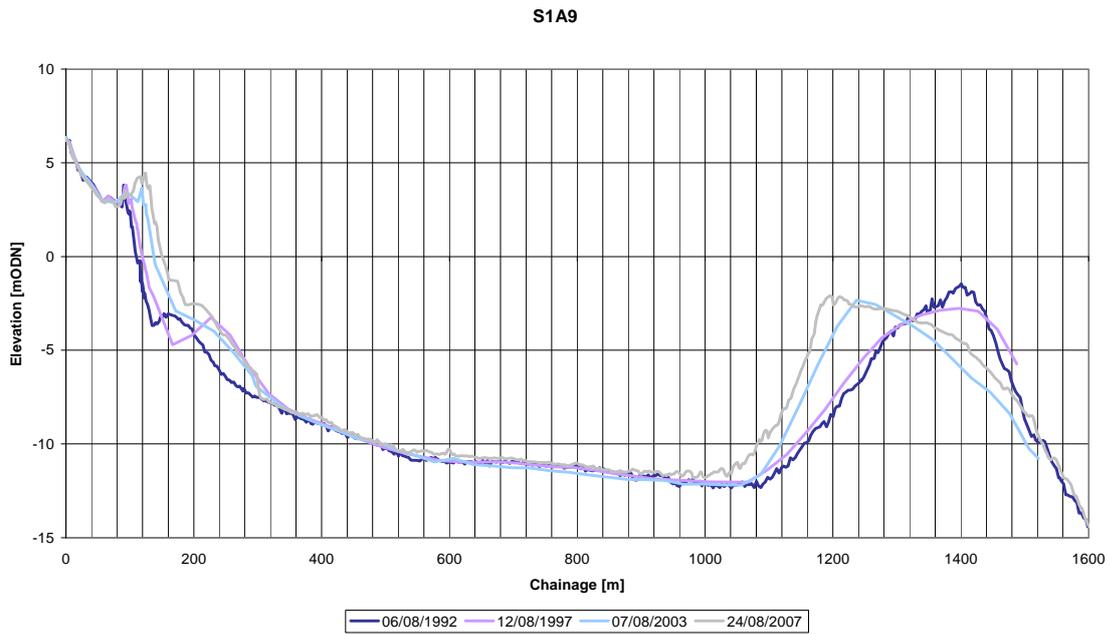
Figure 3.21 Profile S1A9 (out to 1600m): Aldeburgh
