Anglian Offshore Dredging Association

Marine Aggregate Regional Environmental Assessment: Coastal Characterisation

Technical Note TN-DDR4472-02

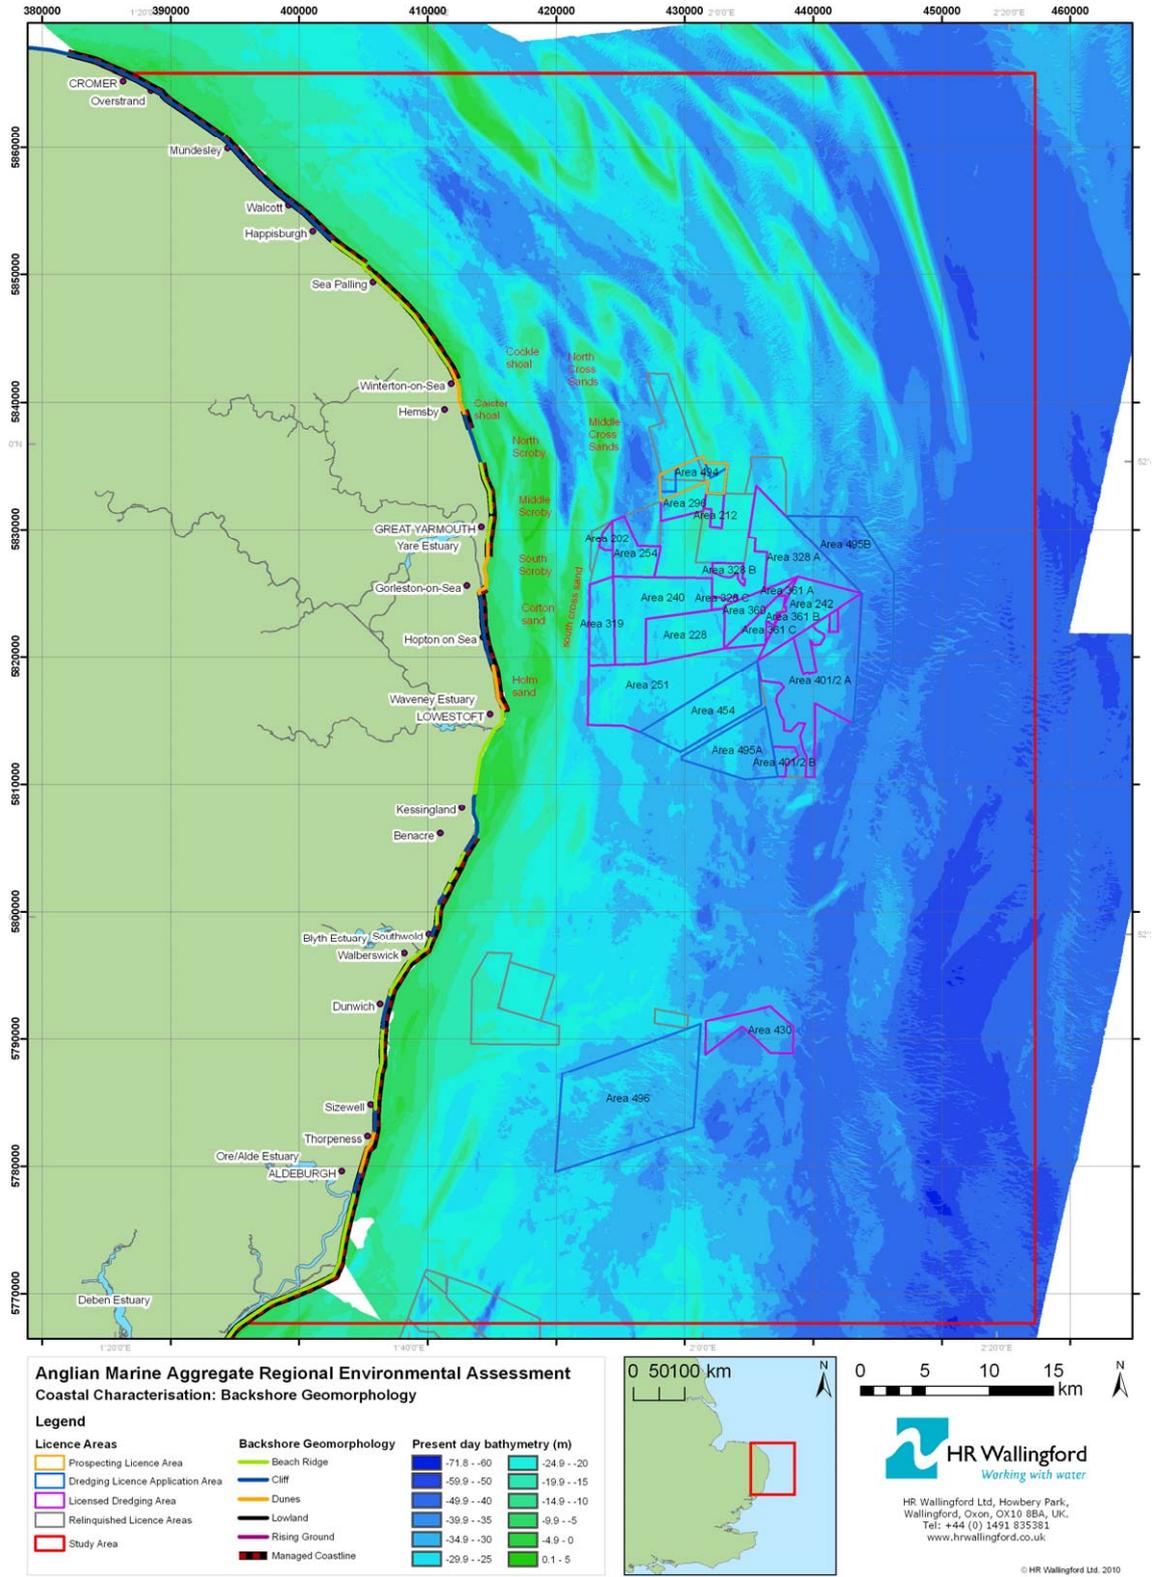
Map 1 Backshore geomorphology and managed coastline

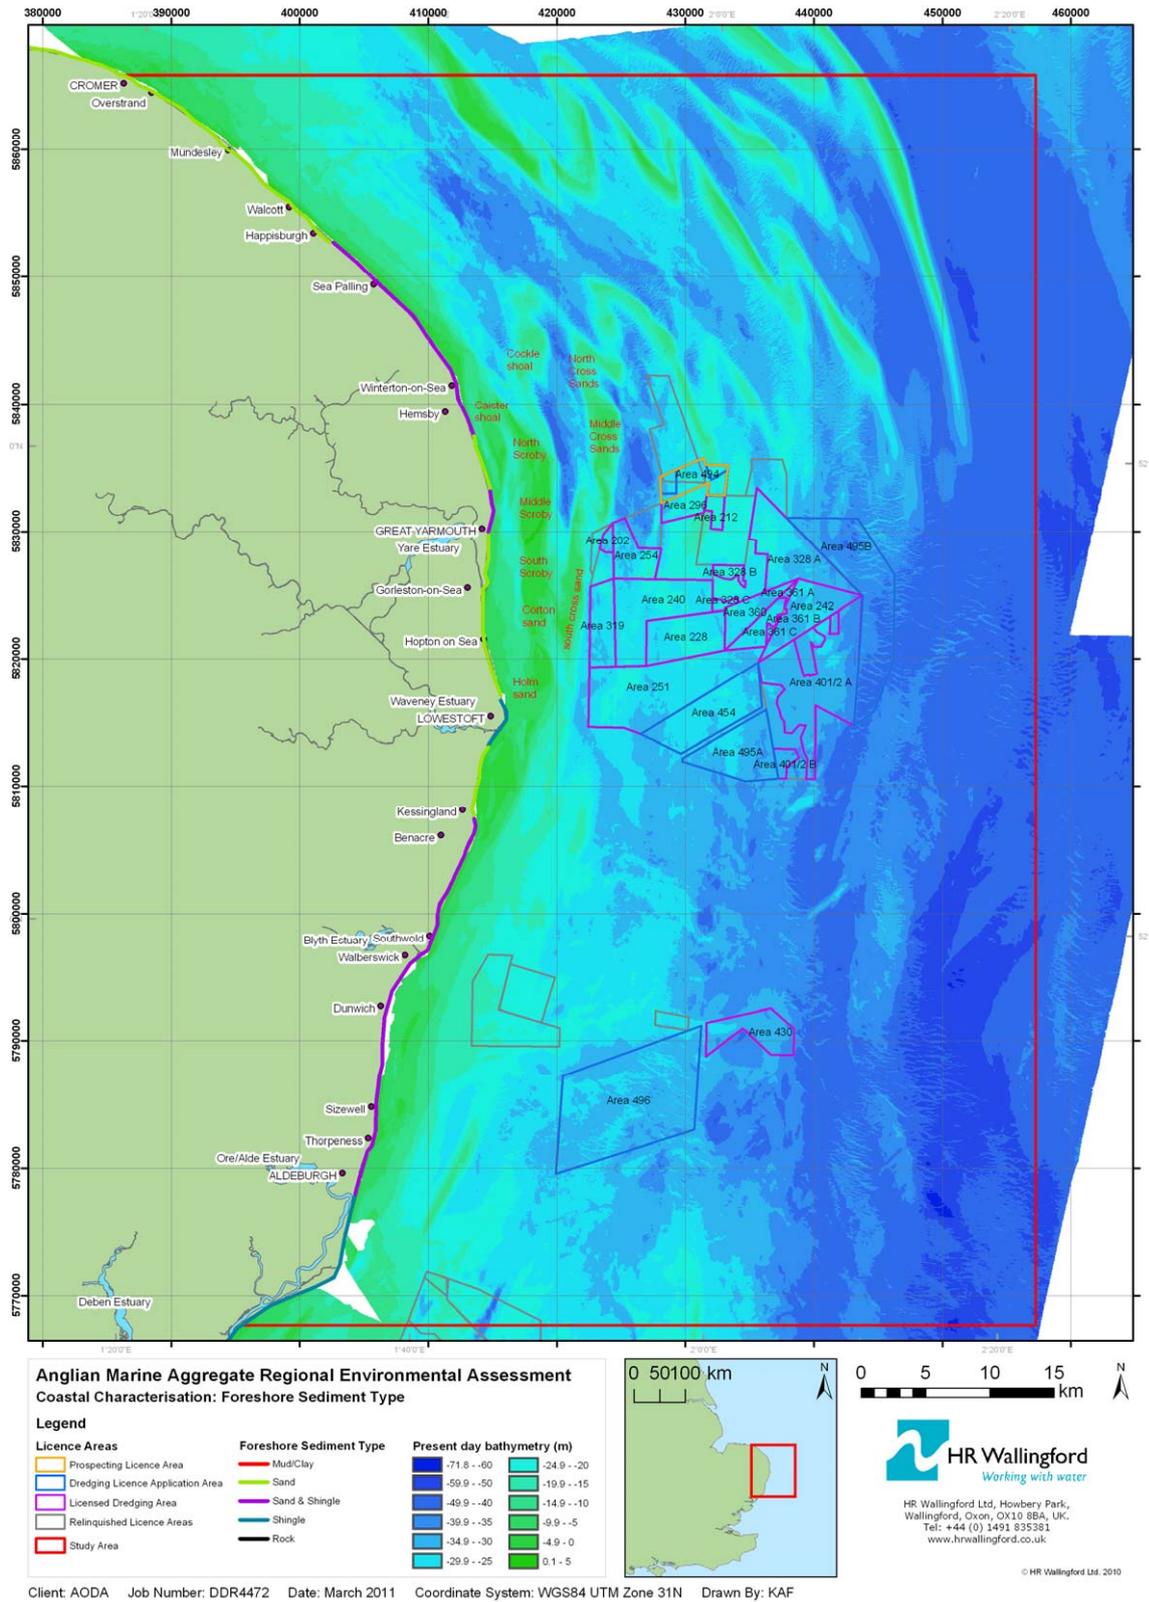
Map 2 Foreshore geomorphology

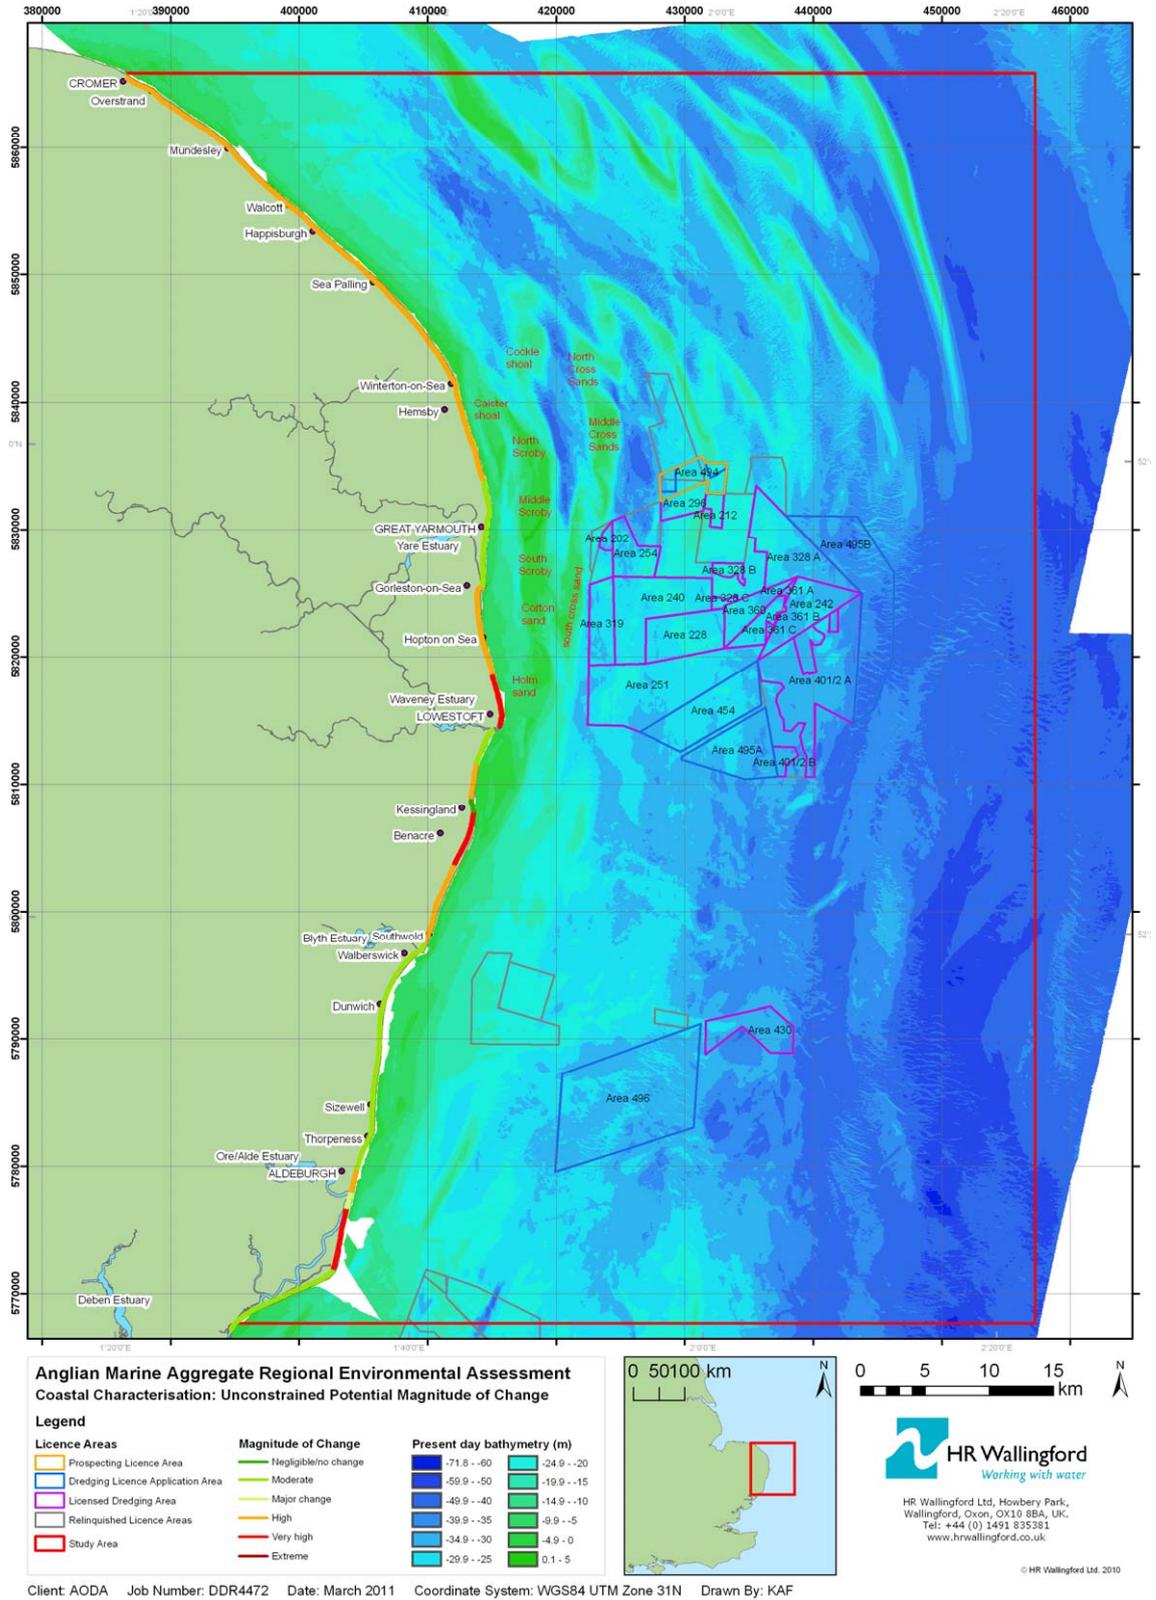
Map 3 Unconstrained potential magnitude of change

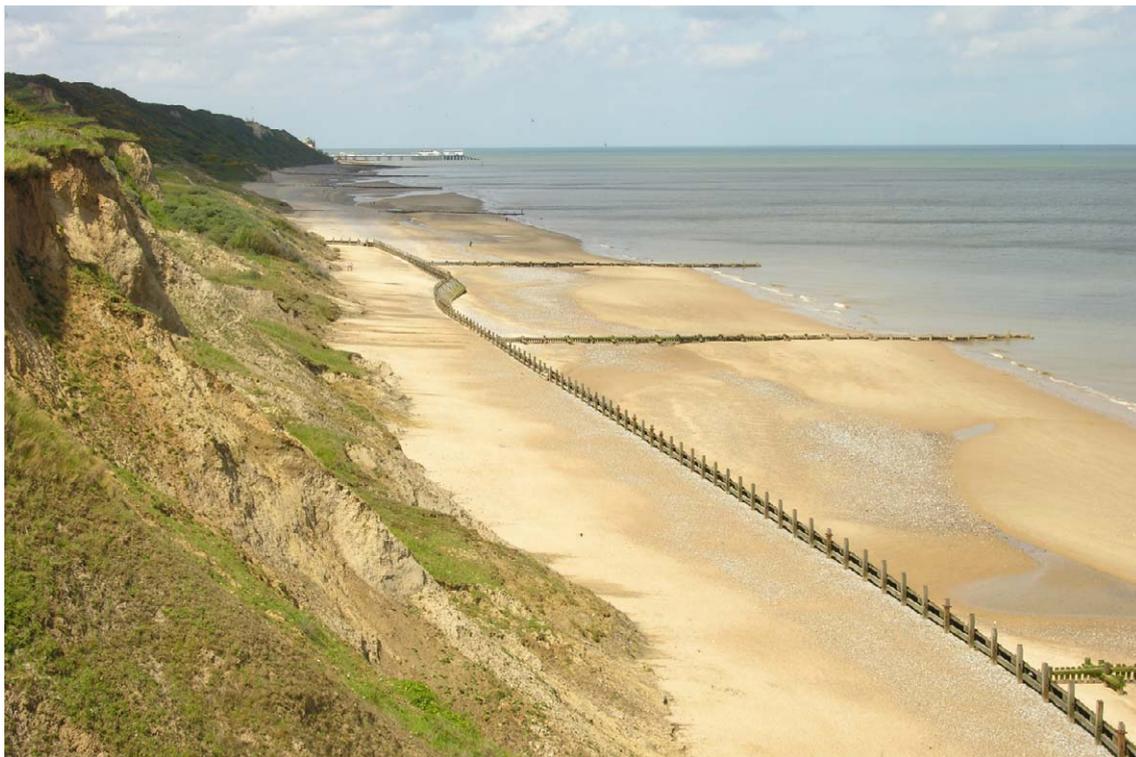
Plate 1 Timber revetment west of Overstrand

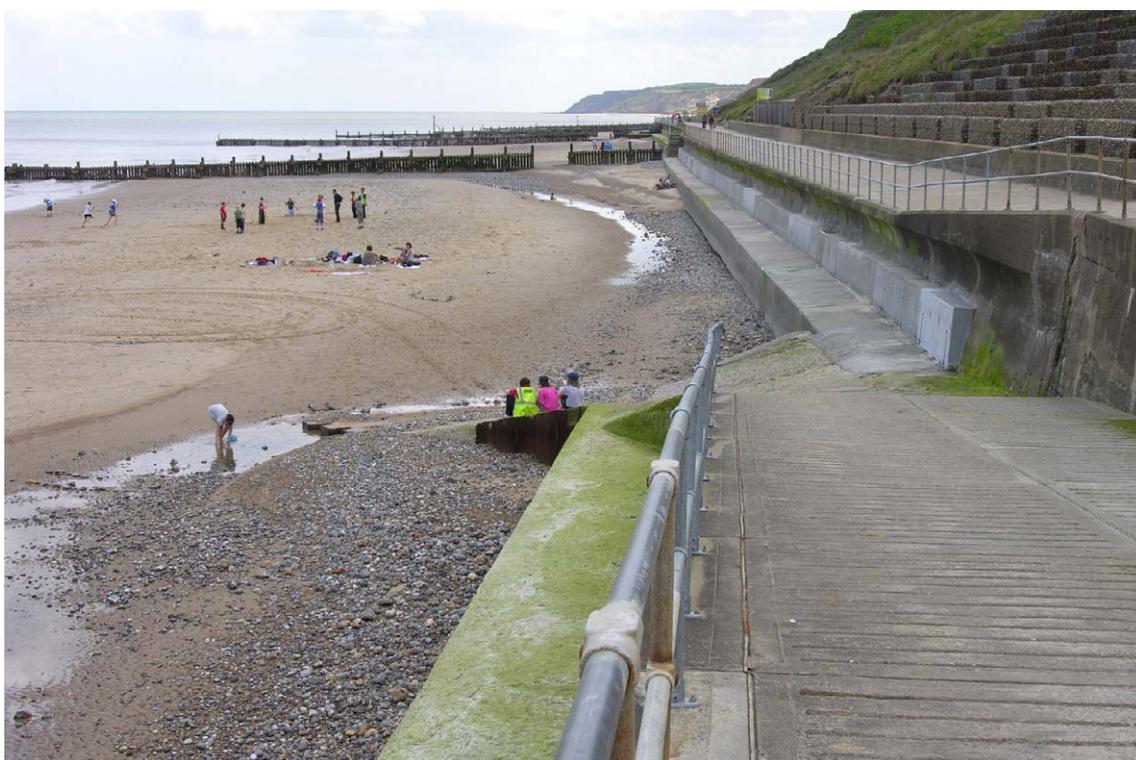
Plate 2 Seawall and gabion cliff protection at Overstrand

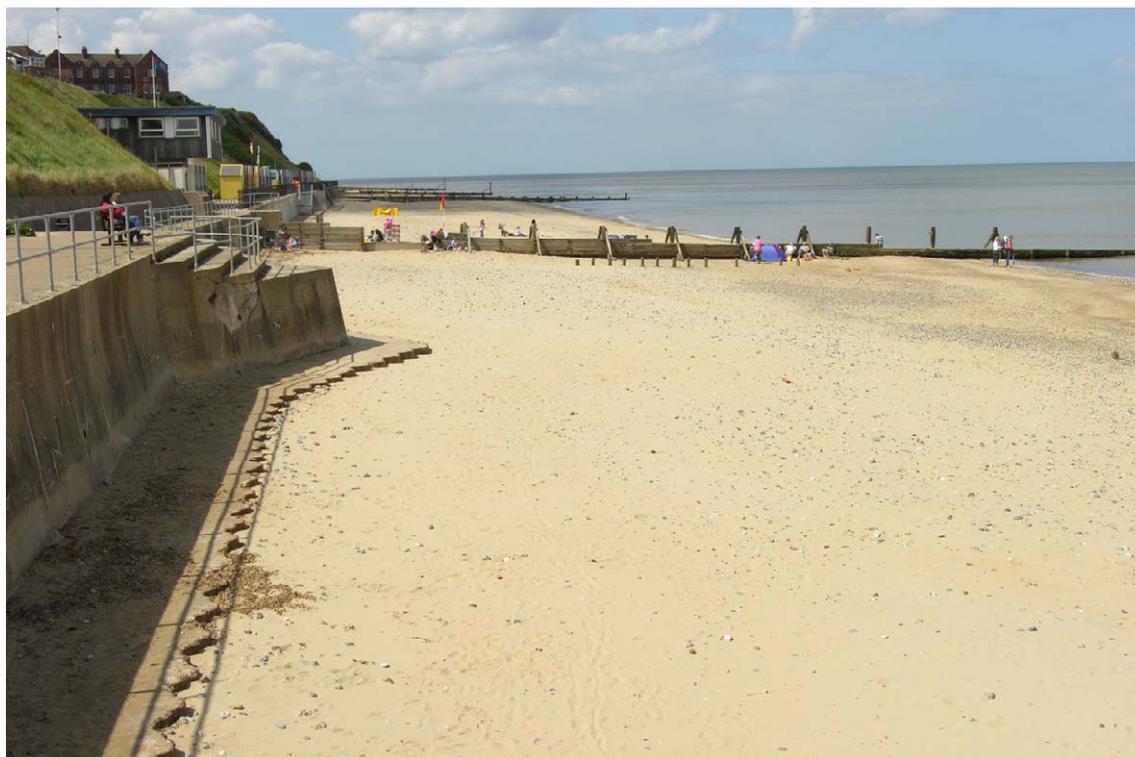
Plate 3 Seawall at Mundesley

Periodic failures of the cliffs have caused extensive damage at the northern of the timber revetment fronting Trimingham, so that the backshore defences there are now discontinuous. Further failures can be expected as the revetments deteriorate (there are no plans to maintain them). The protection by timber revetments and groynes extends to the concrete block cribwork before the well-maintained seawall at Mundesley is reached (see Plate 3).

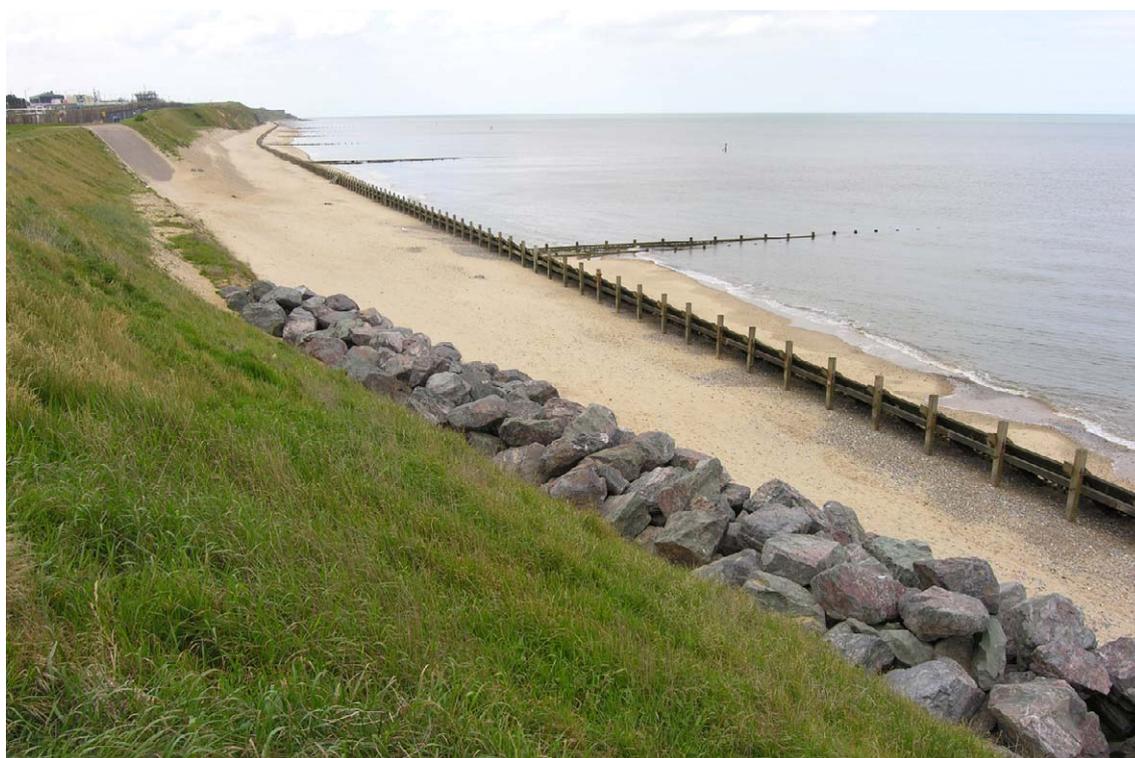
Plate 4 Rock armour protection at Paston

Timber revetments extend from Mundesley to Bacton, where they protect the Bacton Gas Site, located near the cliff top. Both the revetments and the groynes are in reasonable condition along this frontage, whilst the cliffs themselves are more stable than on the frontages further northward/ westward. Cliff recession has averaged at over 1 metre per year over the last century, but has now substantially reduced. Some rock armour protection has been provided to the lower part of the cliff face at Paston (see Plate 4).

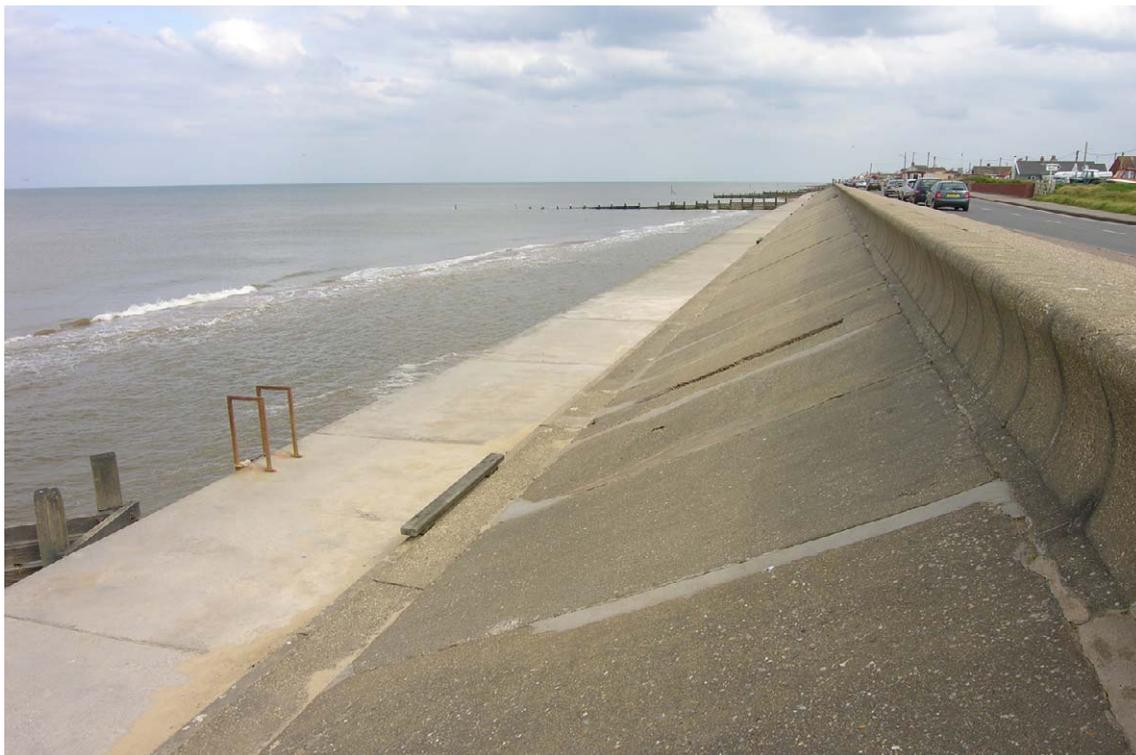
Plate 5 Seawall at Walcott

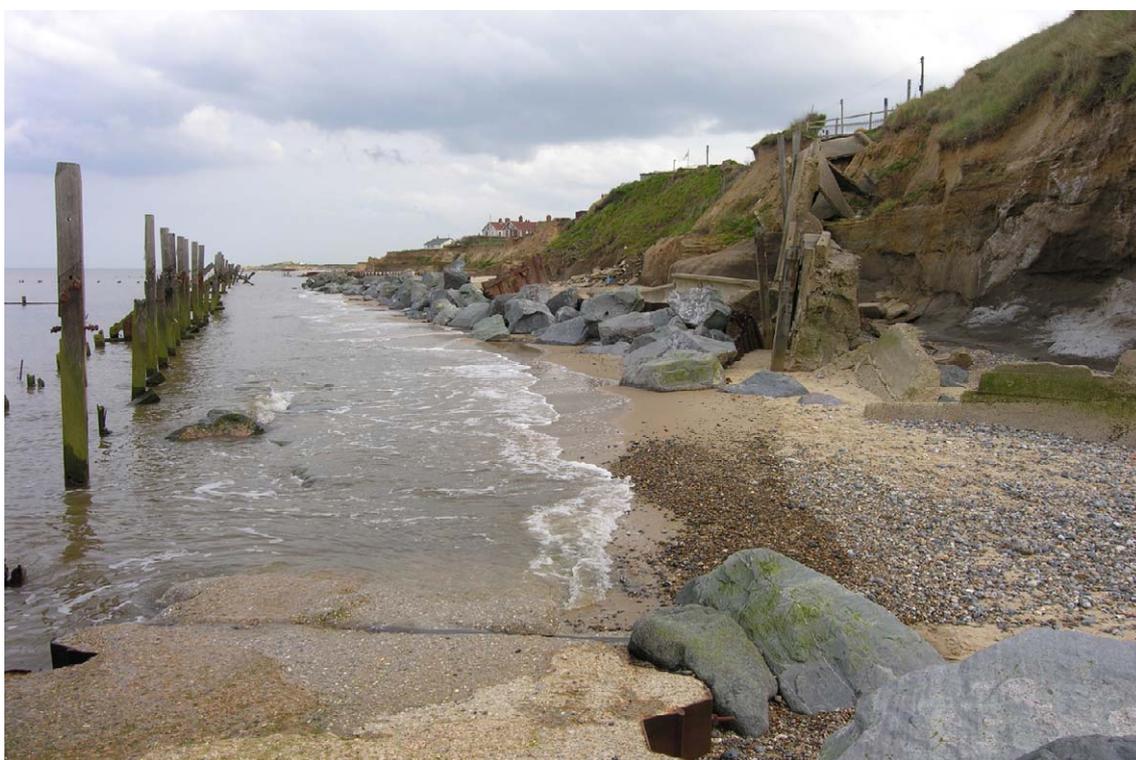
Plate 6 Destroyed sea defences at Happisburgh

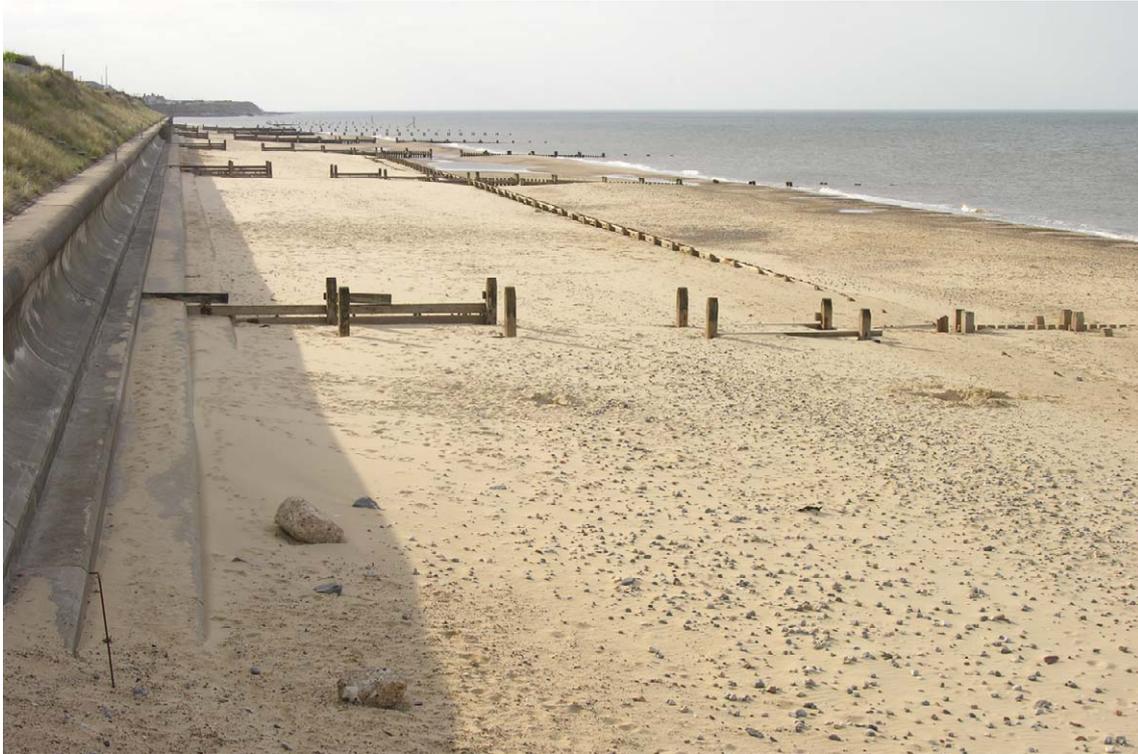
Plate 7 Seawall at Cart Gap, Eccles

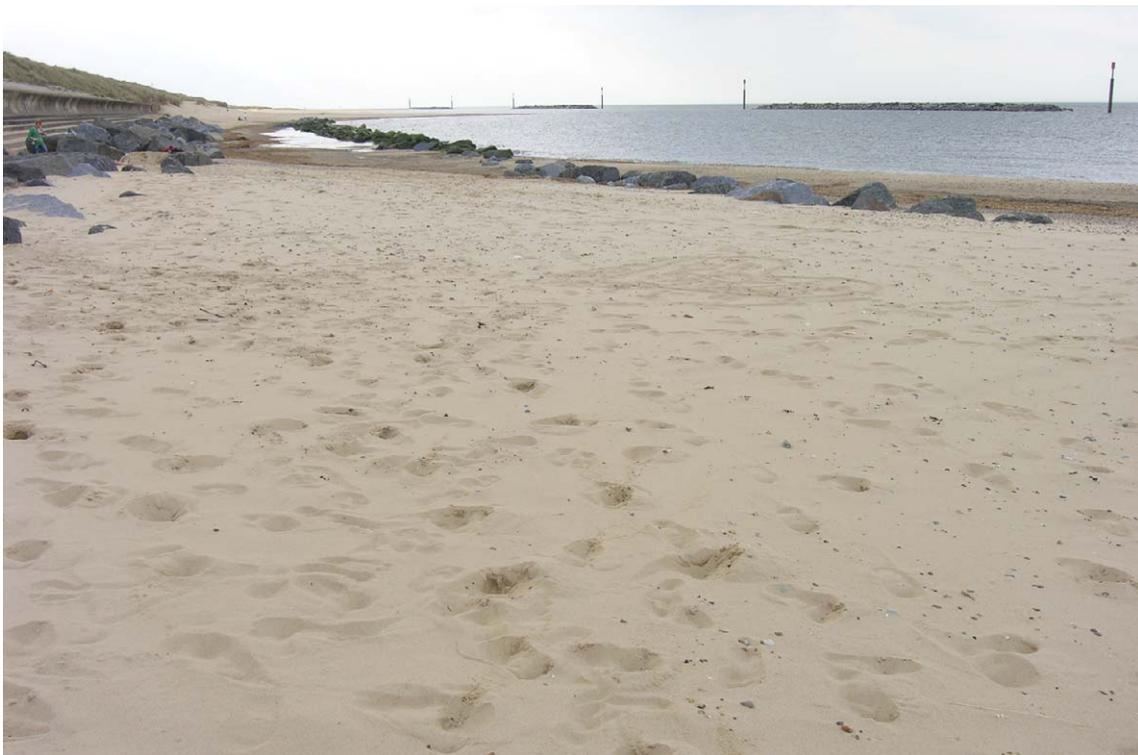
Plate 8 Beach between reefs 3 and 4 at Sea Palling

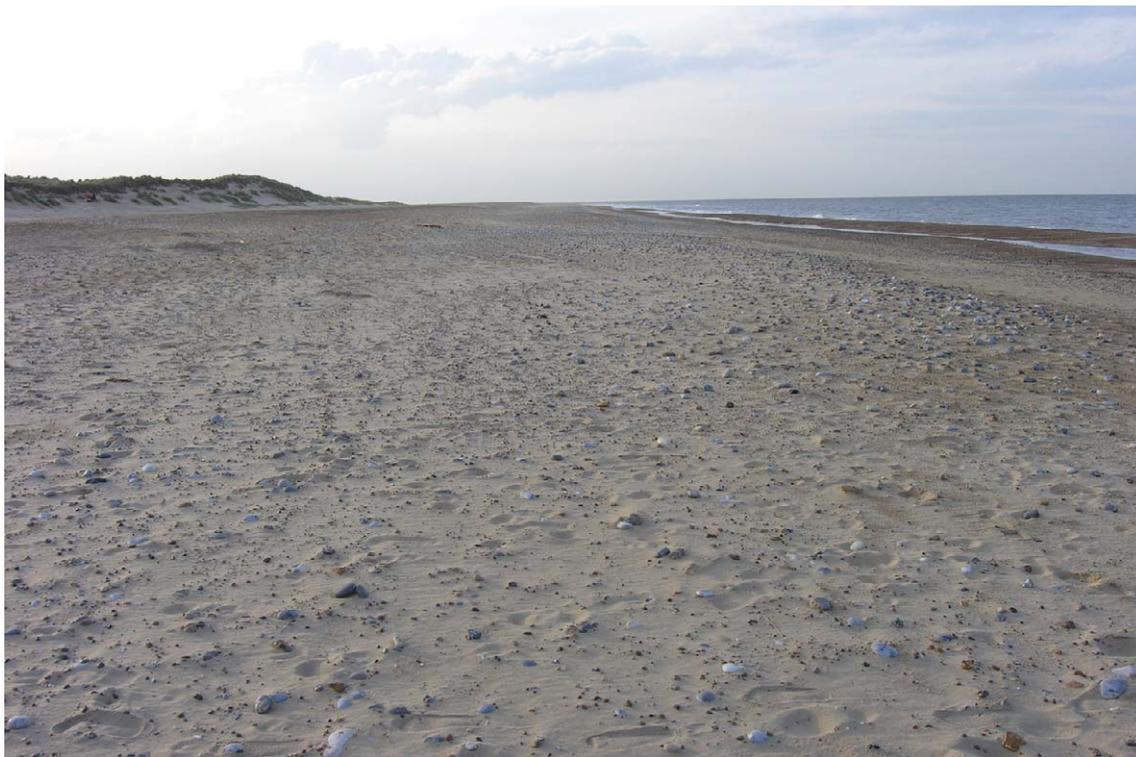
Plate 9 Accreting beach at Winterton

The seawall extends to Winterton Ness, where it disappears behind the line of sand dunes that provide natural protection for the hinterland. The ness appears to have migrated southwards some 1.5km between 1833 and 1966, but has moved northwards in recent years. This alongshore migration is thought to be related to changes in wave activity caused by movements of offshore sandbanks. The area of accretion extends southward to Winterton-on-Sea (see Plate 9), but from there southwards to Hemsby, the beach/backshore width reduces.

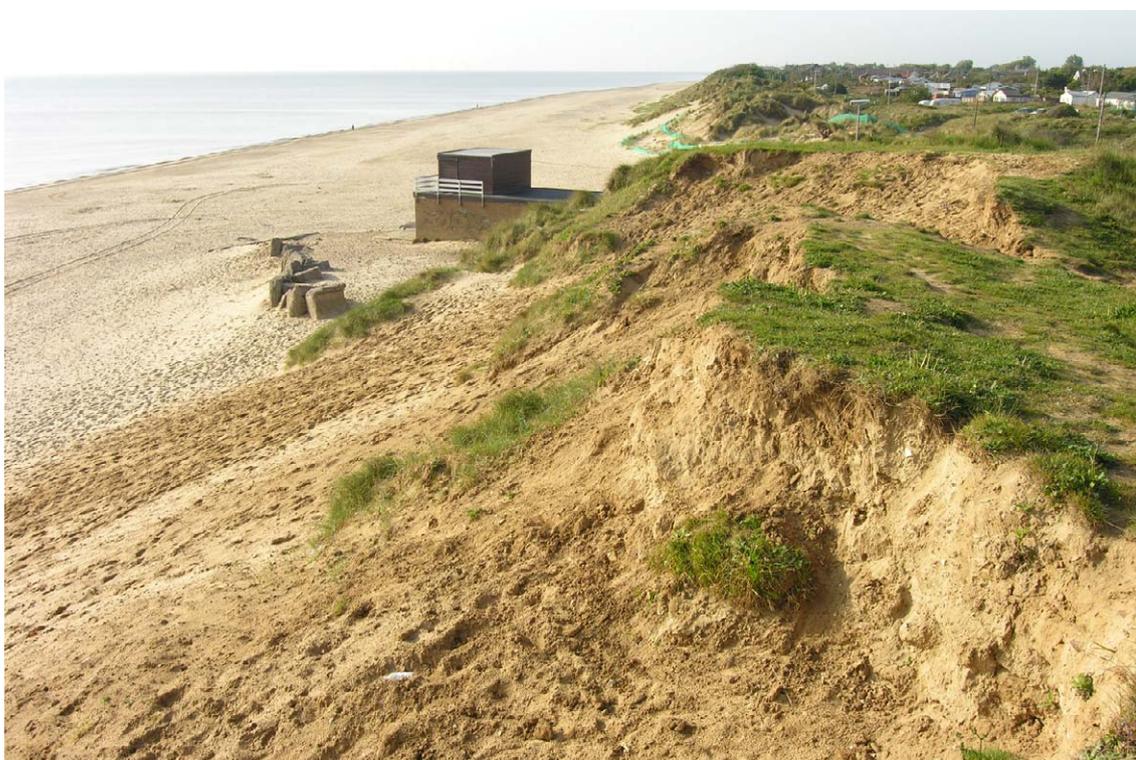
Plate 10 Eroding sand cliffs at Hemsby Hole

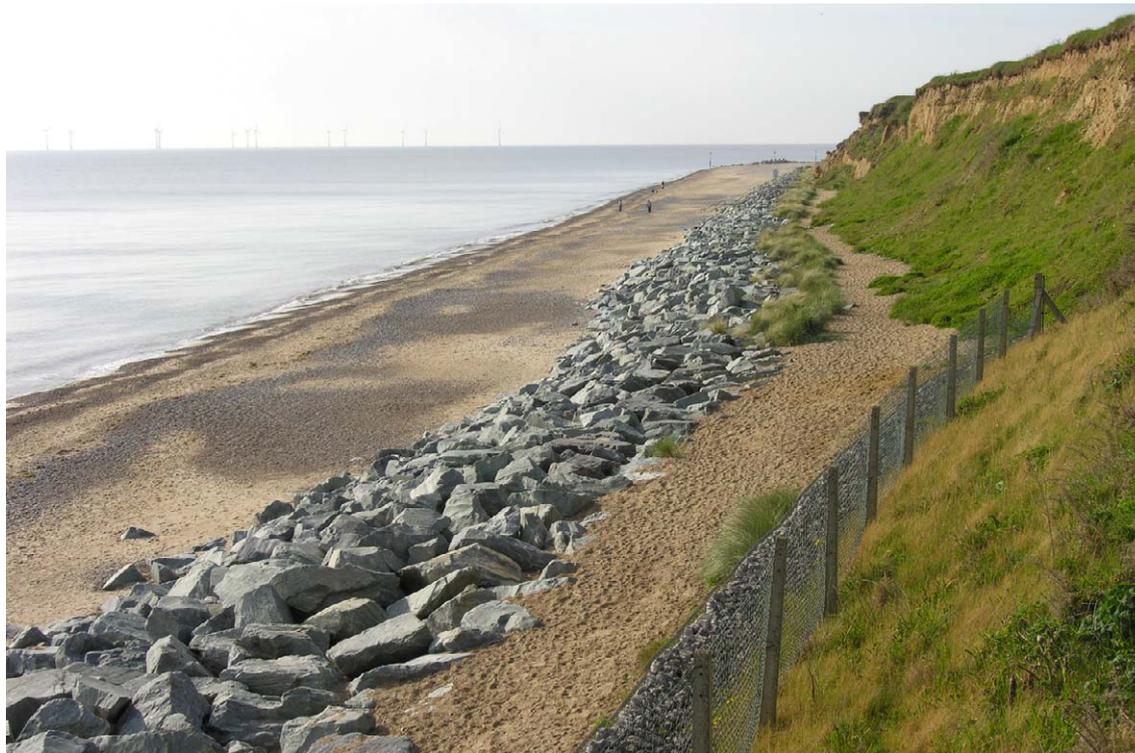
Plate 11 Rock berm in front of cliffs at California

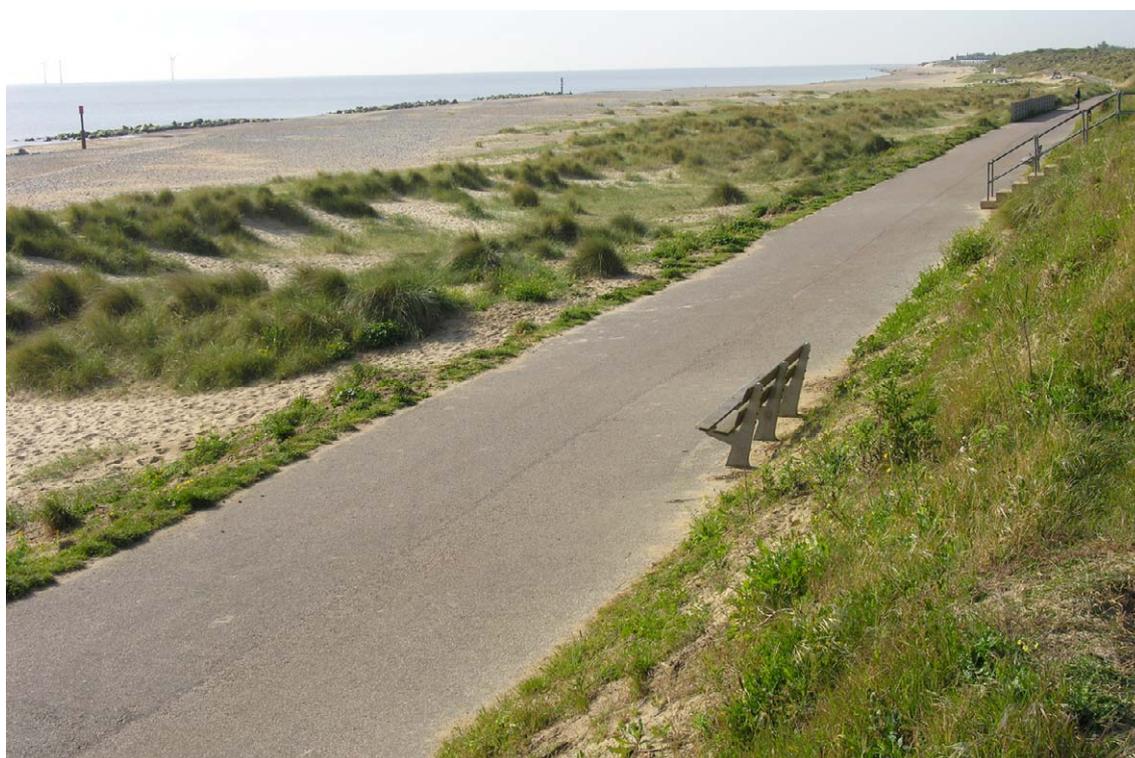
Plate 12 Accretion at Caister-on-Sea

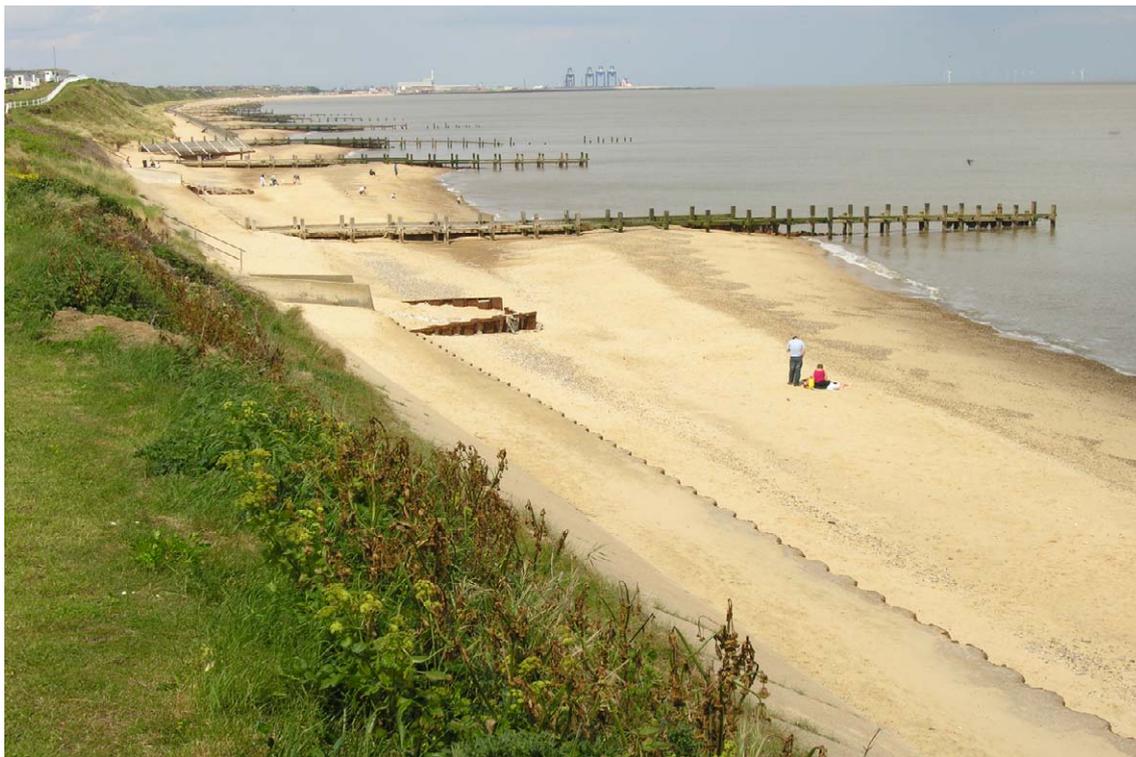
Plate 13 Mixture of defences at Beach Road, Hopton

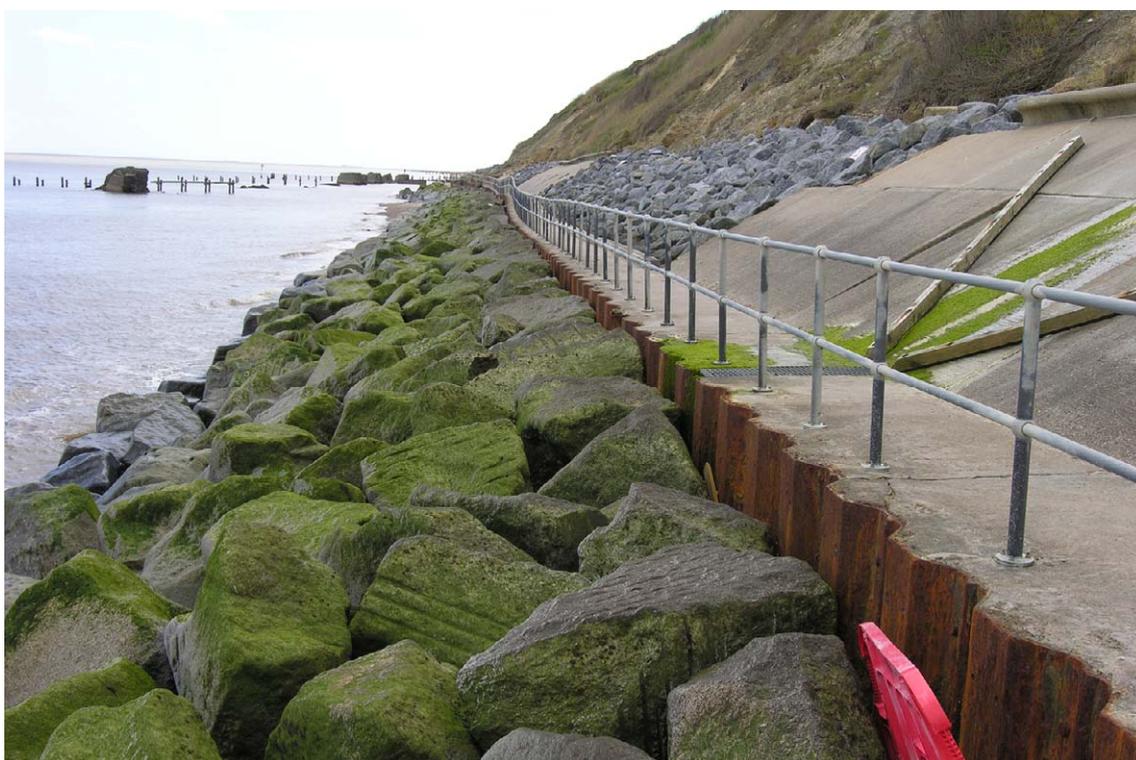
Plate 14 Low beach levels at Corton

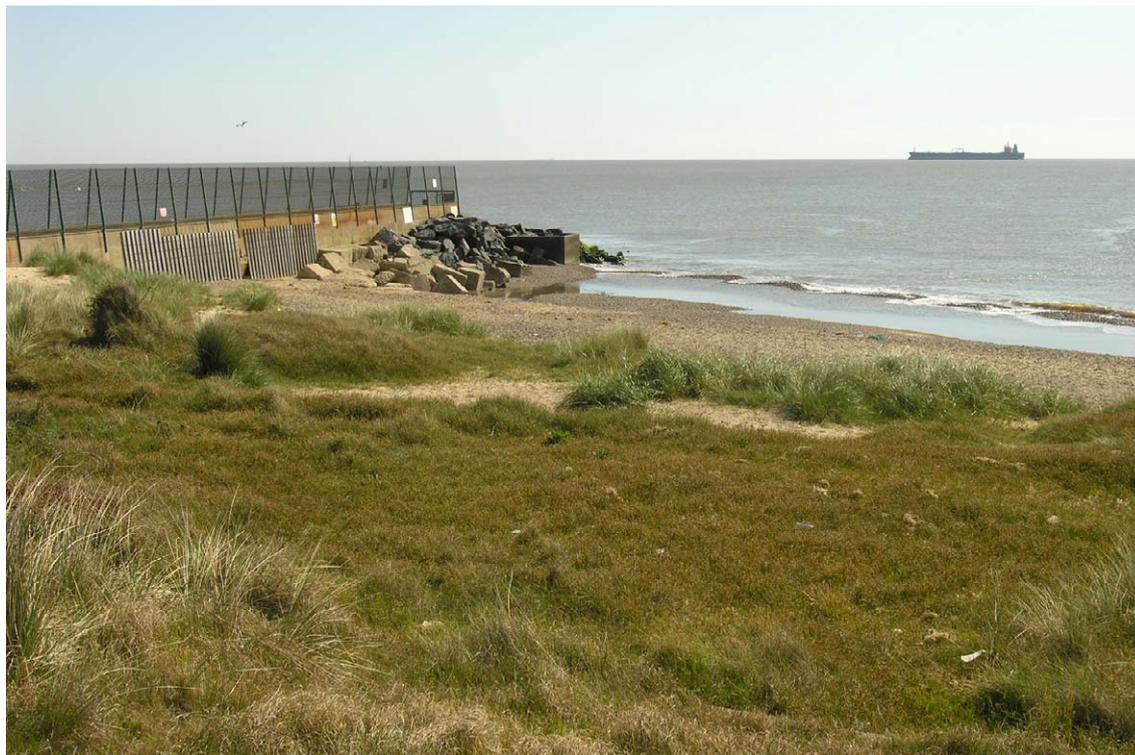
Plate 19 Protection to outfall at Benacre Pumping Station

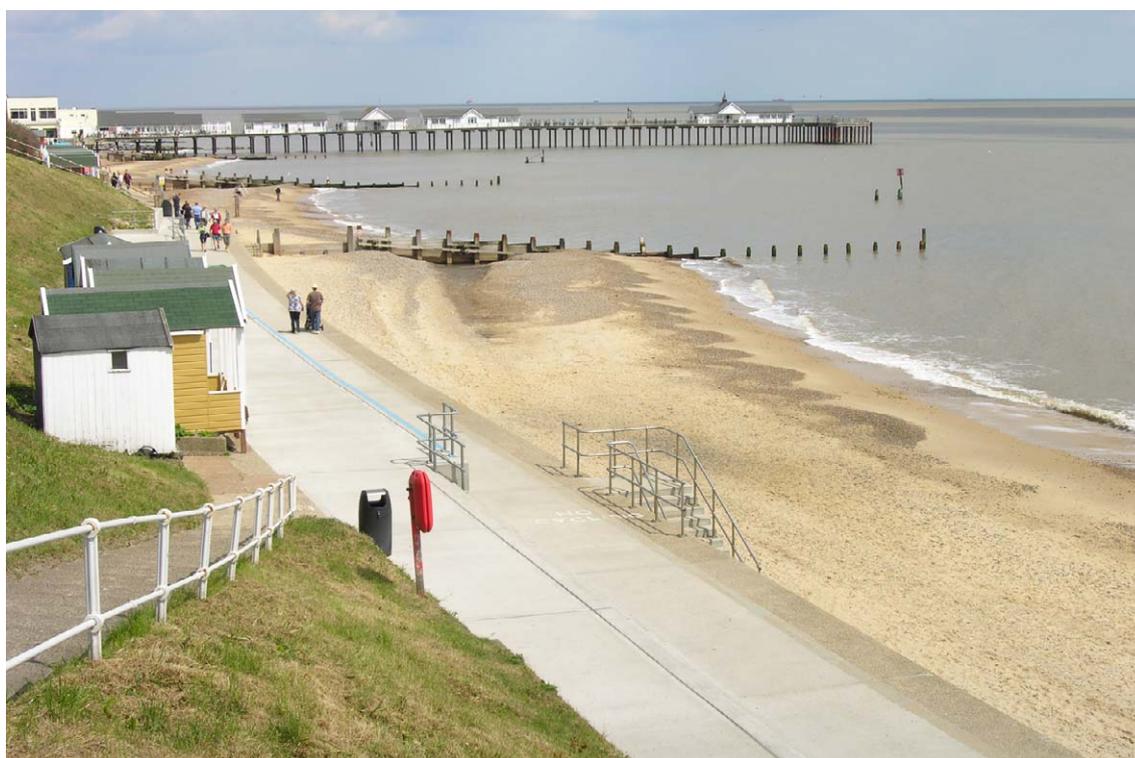
Plate 20 Sea defences at Southwold

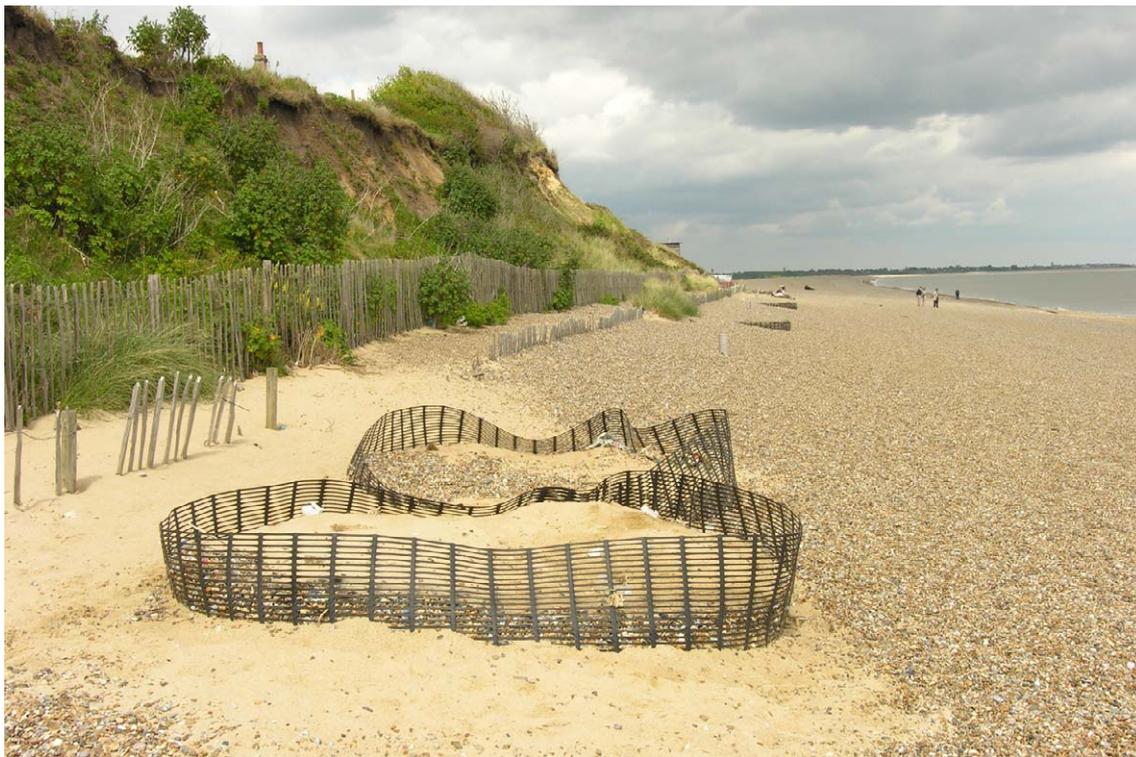
Plate 21 Dunwich Cliffs low cost protection works

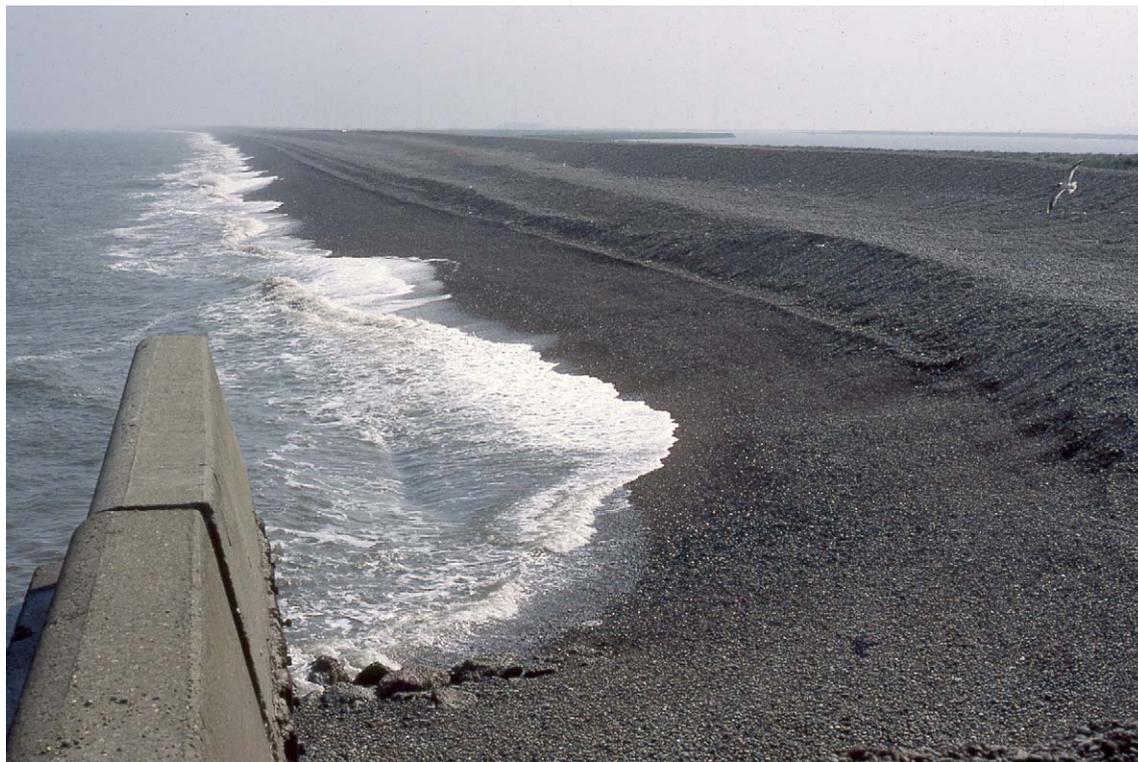
Plate 27 South end of Slaughden seawall in 1983

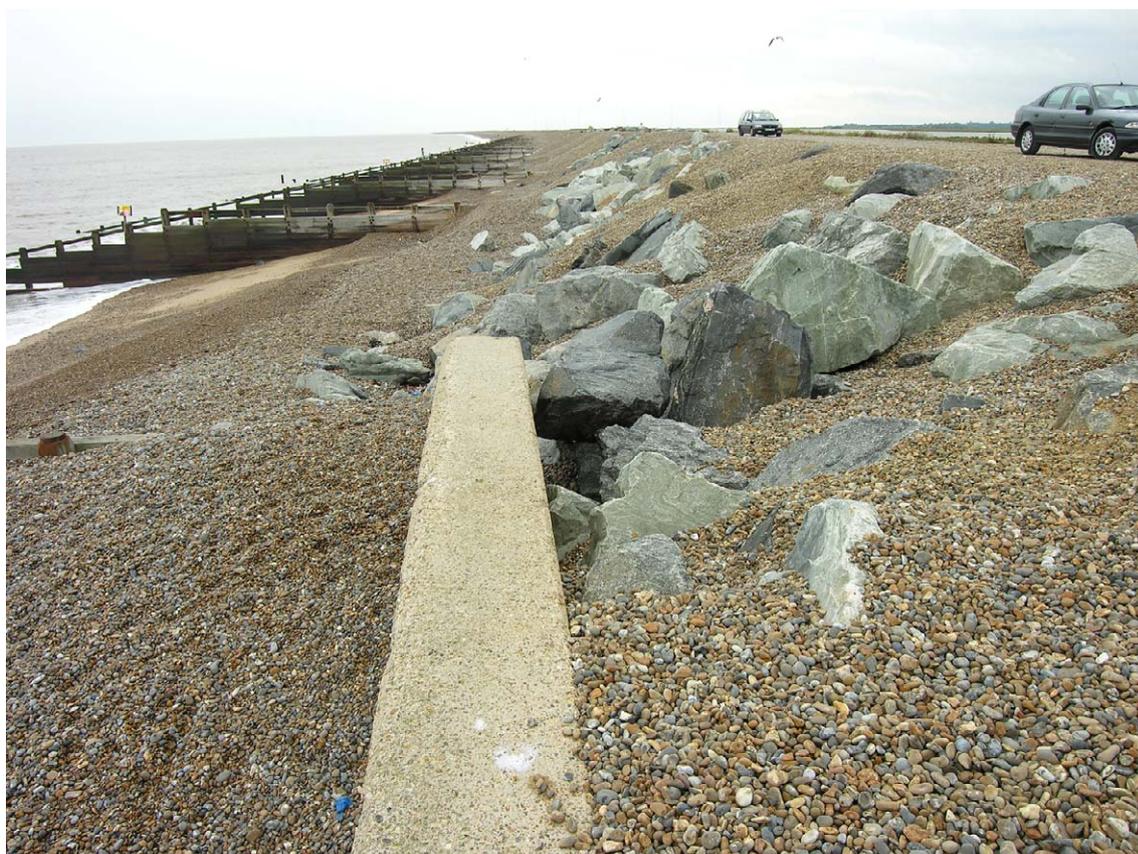
Plate 28 South end of Slaughden seawall in 2008
