Anglian Offshore Dredging Association

Marine Aggregate Regional Environmental Assessment: Coastal Characterisation

Technical Note TN-DDR4472-02

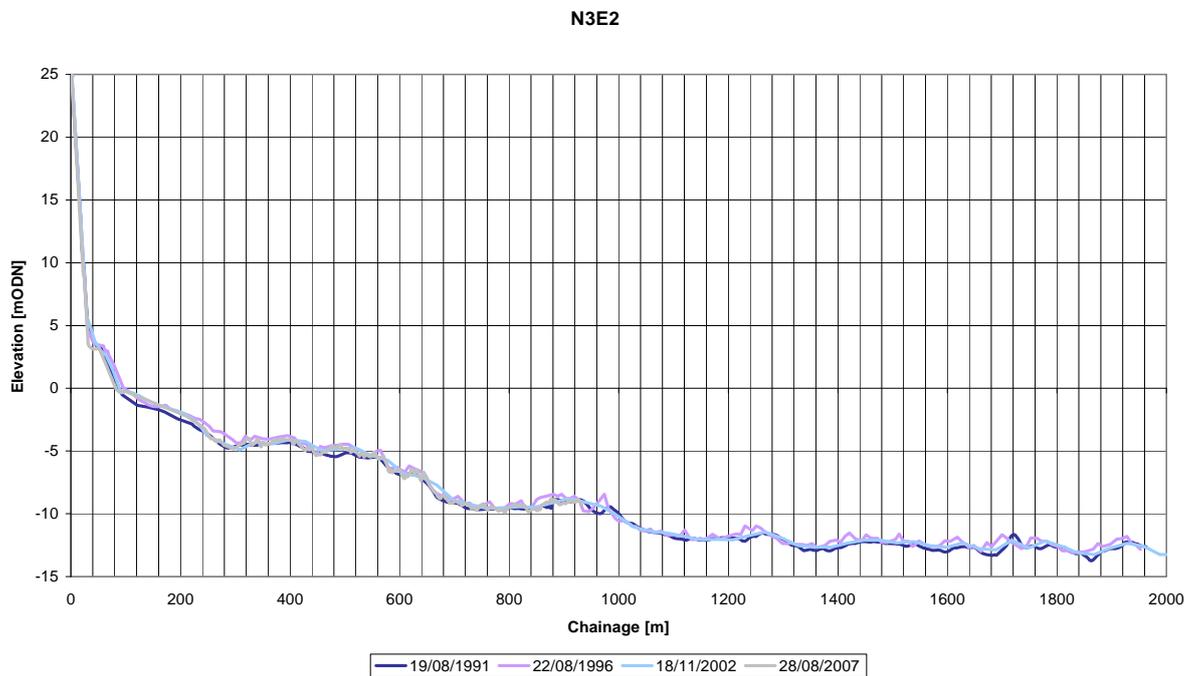
Figure A1 *Cross-sectional profile at Cromer (profile N3E2)*

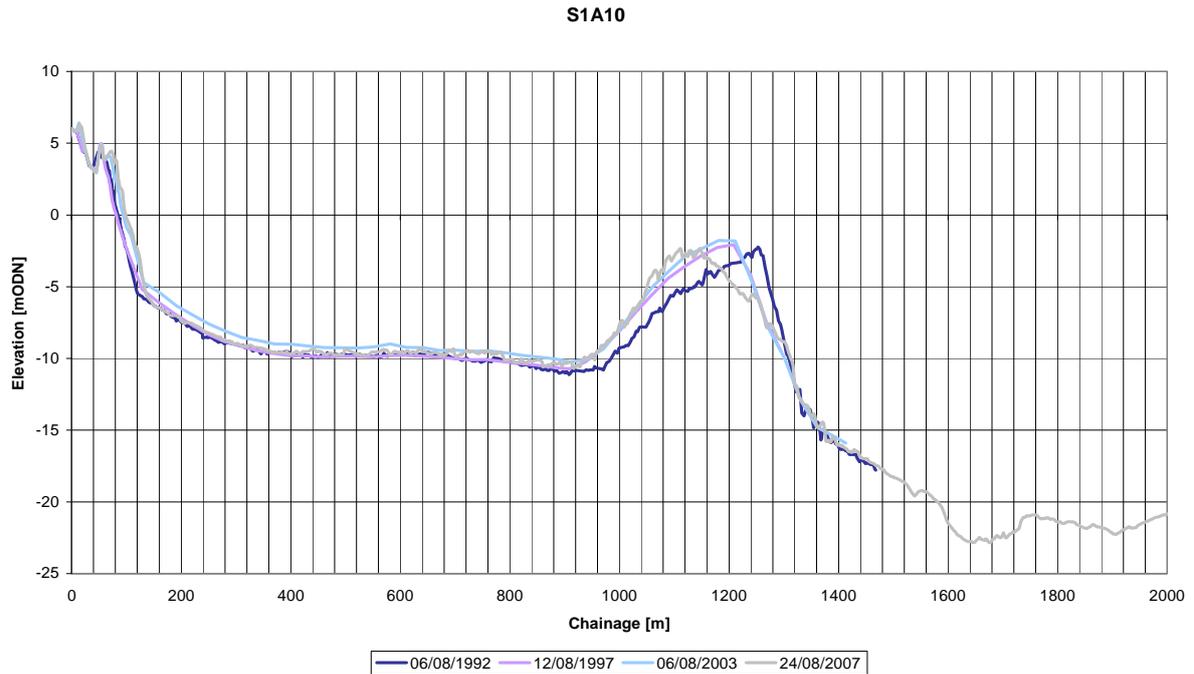
Figure A2 Cross-sectional profile at Orford Ness (profile SA10)

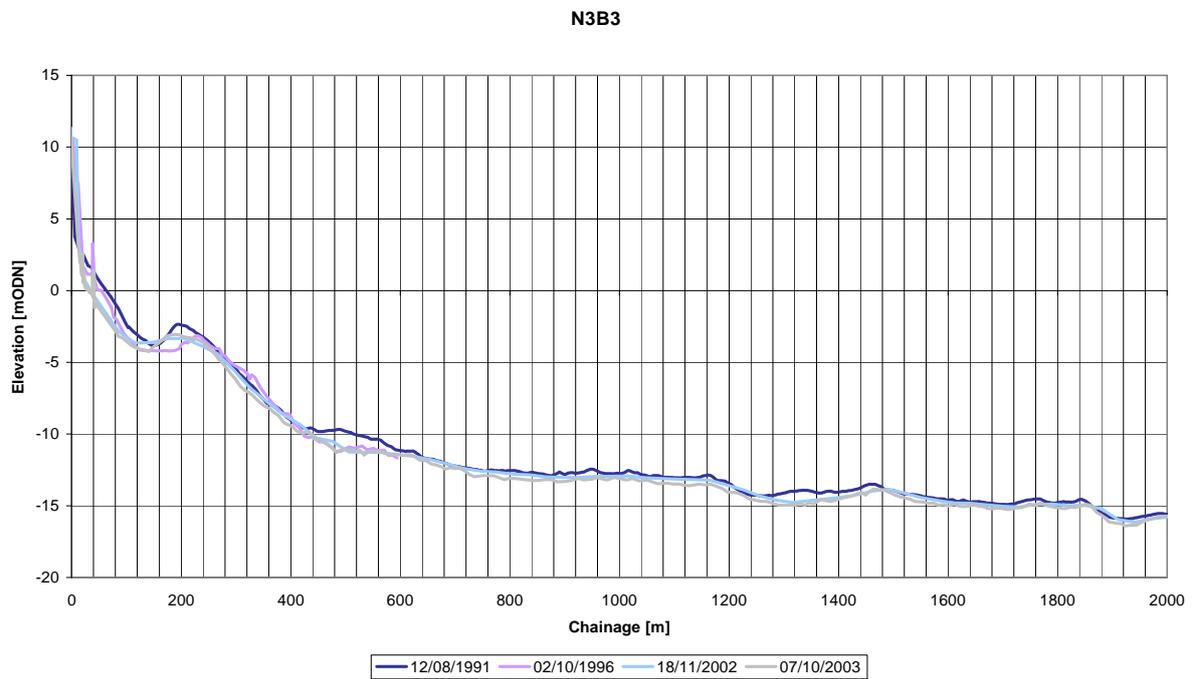
Figure A3 Cross-sectional profile between Walcott and Happisburgh (profile N3B3)

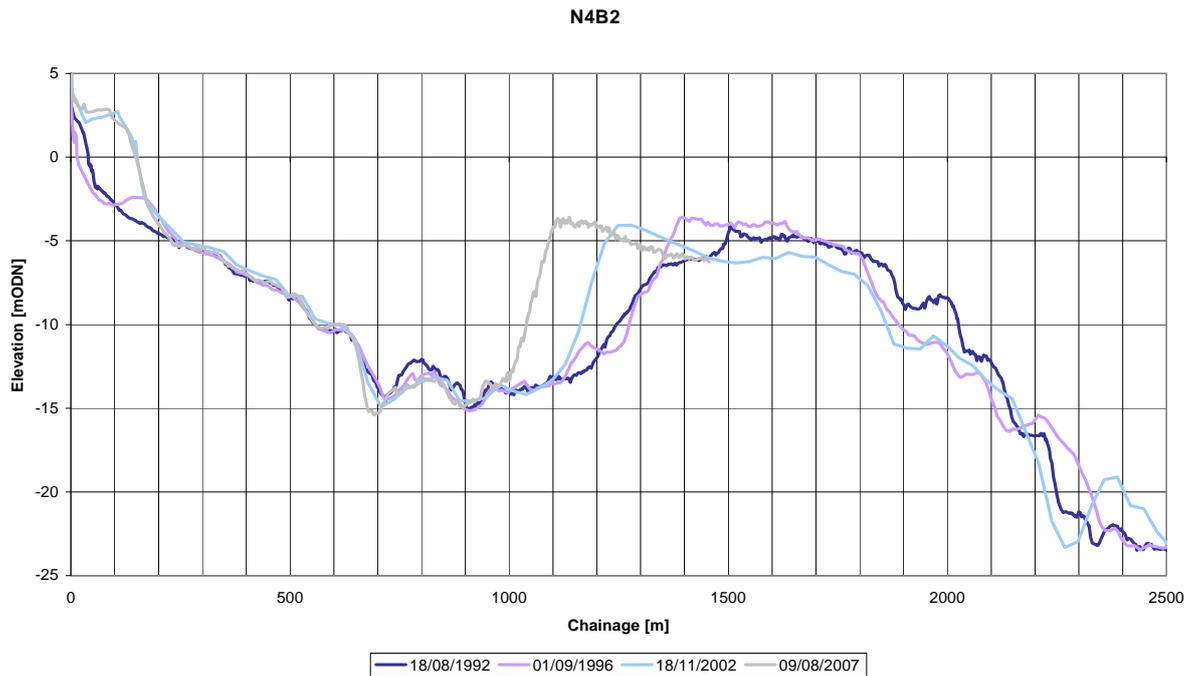
Figure A4 *Cross-sectional profile at (profile N4B2)*
